Numerical and experimental analysis of a mine's loader boom crack

Findings: The causes of damage of a loader jib boom used at an underground copper mine were found.

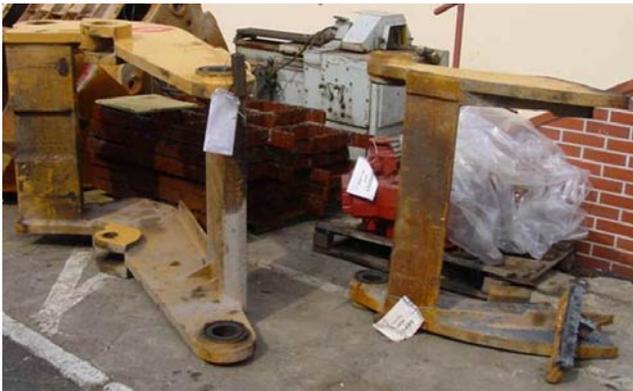
Among the vast number of machines operating in underground mines, we would like to concentrate on loaders. A common fault, which is found in machines of this type is damage to the scoop bucket and the cutting blade. There are also cases related to damage of the frame or the loading jib. During exploitation of one of such machines in an underground copper mine, the jib suffered damage as shown in fig. 2. This consisted of a cross fracture of the jib boom, causing complete separation of the front part of the jib from the rest of the machine. The fault occurred during unloading of the scoop.

Fig. 2. Damaged loader boom

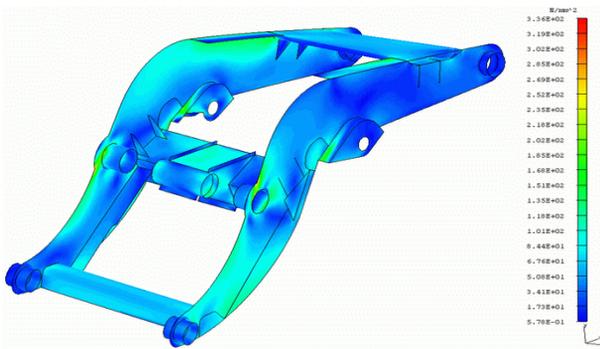
Fig. 5. Contour lines representing stress levels in the boom, according to the Huber-Mises theory

$$\sigma_{MAX} = 413 \text{ MPa}$$

Stress concentration is caused at a structural notch at the boom's actuator mounting point. At this point there is also a change in the rigidity of the boom's side strip caused by the bushing for the actuator mechanism's mounting bolt. This is also the point where the boom cracking was initiated.

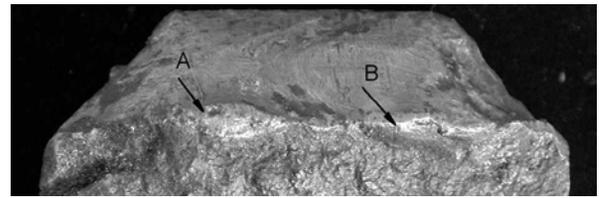
The boom supplied for testing had a fracture running across the entire cross section of the boom (fig. 6).

The fractographic analysis concluded that the fracture was an immediate brittle fracture, originating at points marked A and B in fig. 6, located along the S1 weld joint fusion with the boom material. Analyzing the surface topography of the fracture points A and B using a scanning electron microscope showed a smoothed surface, which is characteristic for fracture origination points. The fractures at points A and B probably originated already during or shortly after welding, and ultimately lead to an immediate brittle fracture of the jib boom. It is also probable that the welding fractures lead to a small fatigue zone. Surface morphology observed at point A is shown in fig. 7.

Fig. 6. Topography of the fracture zone

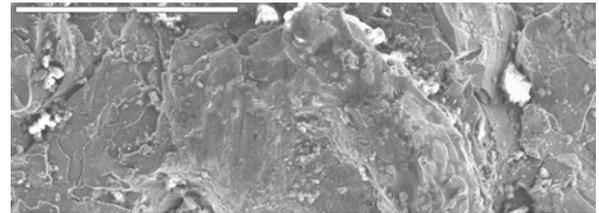
Fig.7. Surface morphology at point A - fig.6. SEM image

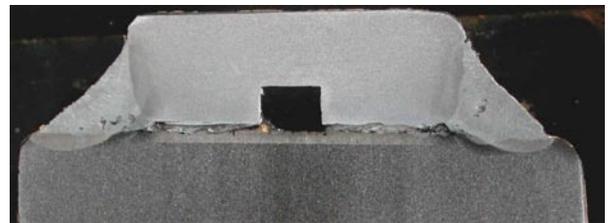
Macroscopic evaluation of the weld joint was performed at the cross microsection of the S2 fillet weld (fig. 8). The weld surface was etched using Adler's etching solution (Ma11Fe).

Observations proved incomplete weld penetration at the root of the fillet weld. Both welds as well as the weld fusion line also exhibited numerous welding errors in the form of interruptions as well as gas bubbles. The macrostructure examination of the weld joint also revealed various structures in the flat bar, jib boom and weld joint materials as well as within the HAZ (heat affected zone).

Fig. 8. Weld joint between the flat bar and jib boom

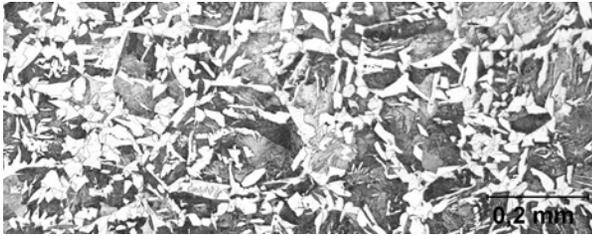
After etching with Mi1Fe it was concluded that the jib boom material microstructure outside of the weld joint is a ferritic-perlite structure exhibiting slight characteristics of a Widmannstätten structure (fig. 9). This type of structure results in weakening of the mechanical parameters and also causes problems during welding, because of the non-homogeneous chemical composition of the material. The weld area has a perlite (pseudoeutectoid) structure with local occurrences of bainite. The pseudoeutectoid structure of the joint suggests that welding was performed using a medium carbon welding rod.

Fig. 9. Microstructure of the jib boom material

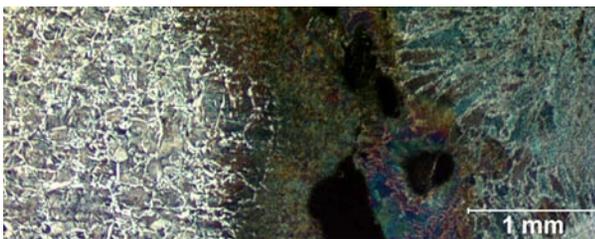
The heat-affected zone exhibits small plate perlite structures as well as areas of martensite structure, where the HAZ was hardened, thus leading to formation of brittle cracks. When comparing the jib boom material and the HAZ there is a clear difference between the ferritic-perlite structure of the jib boom and the perlite structure of the HAZ and weld joint. This rapid change of structure leads to significant change of parameters at the connection of the welded material and weld joint. It suggests

also, that the weld was performed using an improper welding rod, having a significantly different composition as compared to the welded materials. The microstructure of the weld joint, HAZ and the welding errors are shown in fig. 10.

Fig. 10. Microstructure of the weld - HAZ and weld joint
