## Investigations of causes of dumping conveyor breakdown

**E. Rusiński\***

Institute of Machines Design and Operation, Wrocław University of Technology,  
ul. Łukasiewicza 7/9 51-370 Wrocław, Poland

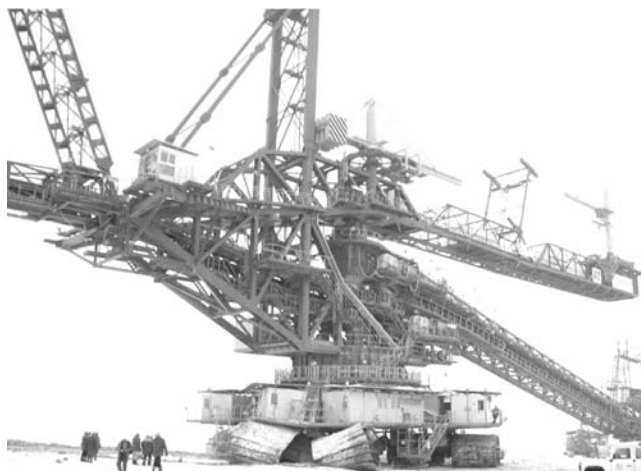
The overburden which is to be removed from an open pit being mined is transported to dumping conveyor which distributes it on the dump. The dumping conveyor's steerable carriage (fig. 3) broke down during work in winter conditions. The dumping conveyor's driving system consists of one steerable and two nonsteerable caterpillar units. The steerable caterpillar unit is made up of two crawler frames, a carriage and a steering frame. A schematic of the steerable caterpillar unit is shown in fig. 4.

Fig. 3. Breakdown of dumping conveyor's steerable carriage

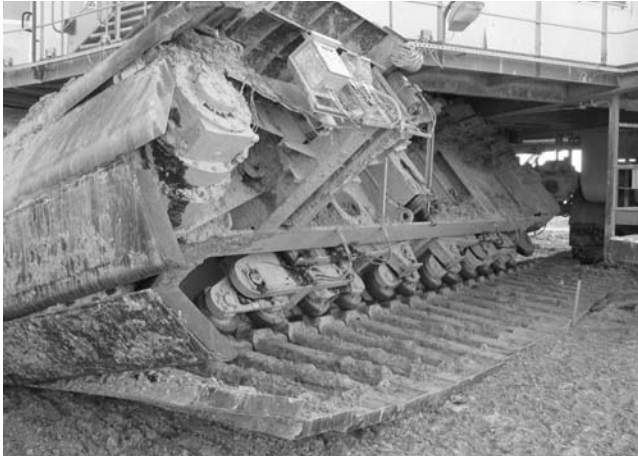
The breakdown occurred because one halfshaft slipped out as a result of damage to its slip-out protection. The track girder after the breakdown is shown in fig. 6.

Fig. 6. Breakdown of one carriage: results of steerable carriage breakdown

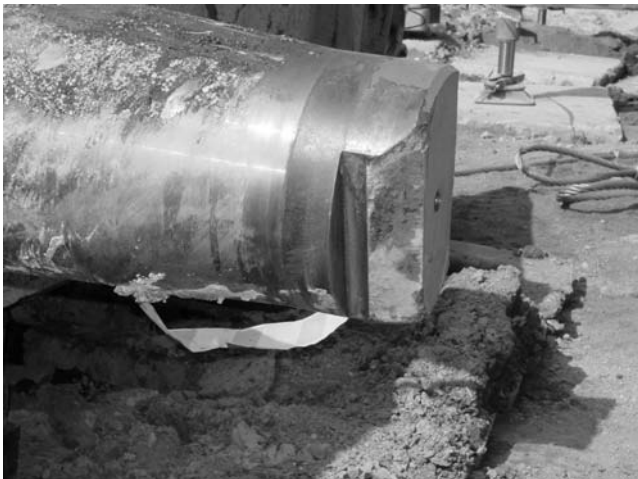
After the dumping conveyor's gantry together with the machine body had been hoisted and the track girder had been removed the damaged end of the halfshaft could be examined. The halfshaft's damaged end with broken off pieces is shown in fig. 7.

Fig. 7. Damaged halfshaft of steerable carriage

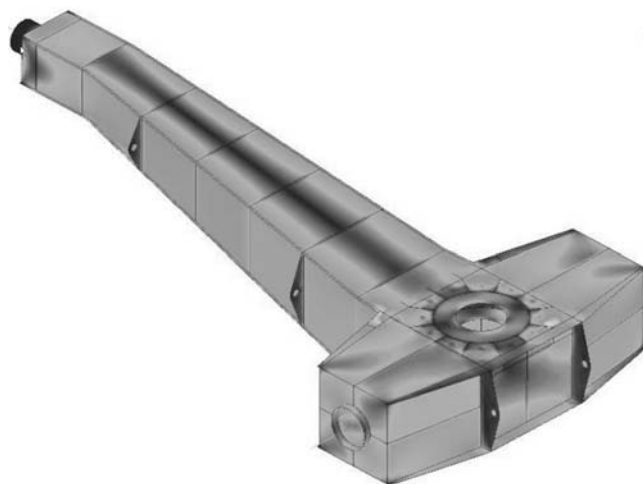
Fig. 9. Distribution of Huber - Misses stress in dumping conveyor's steering carriage

For all the required cases of loading no stress levels specified by the standard [1] were found to be exceeded. High stresses were observed only in the vertical ribs of the halfshaft's housing.

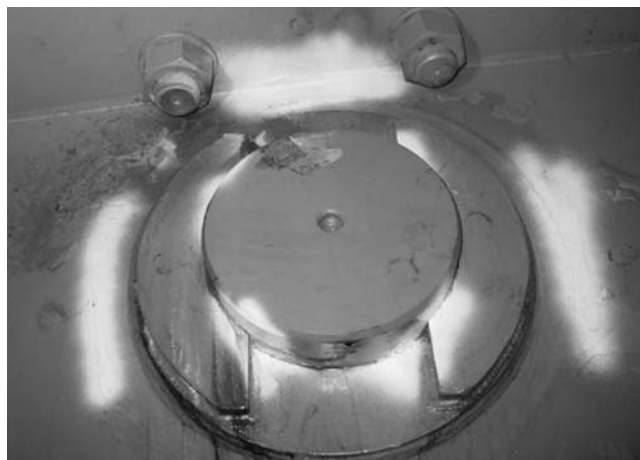
The loads acting on the halfshaft, particularly on its end where the slip-out protection is situated, were analyzed. Considerable axial forces produced by the side shearing of soil occur during curvature travel. In unfavourable conditions they and the lateral forces due to the gradient and wind pressure may add up. The protection against halfshaft slip out is shown in fig. 10.

Fig. 10. Halfshaft end - protection against slip out

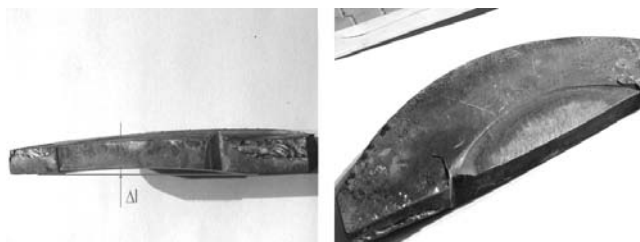
The plates protecting the halfshaft against slip out were deformed (fig. 11) as a result of the longitudinal movement of the halfshaft.

Fig. 11. Deformed elements (plates) protecting against halfshaft slip out

Due to the axial clearance of the halfshaft static friction  $\mu = 0.09-0.14$  becomes sliding friction  $\mu = 0.01-0.05$ . One should note that in this case sliding friction should not occur, but it did occur as evidenced by the deformation of the protective plates (fig. 11). FEM calculations of the halfshaft end were carried out for the most unfavourable case of loading. One should note that because of the very small rounding radius at the bottom of the groove for the protective plates considerable stress concentrations arise under the action of axial forces. The radius is as small as  $r = 0.2$  mm (as measured on microsections of the protection). The halfshafts were made of toughened constructional alloy steel 42CrMoS4 whose yield point is  $R_e = 880$  N/mm<sup>2</sup> and strength  $R_m = 1030$  N/mm<sup>2</sup>. The FEM strength calculations of the halfshaft were performed for two values of the axial force acting on the halfshaft protection:

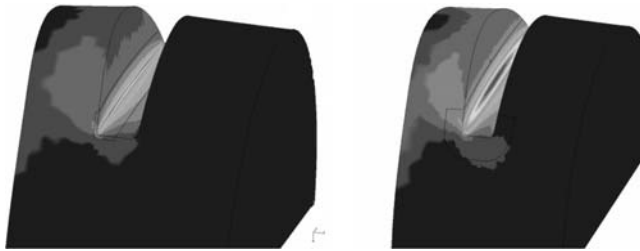
Fig. 12. Distribution of Huber-Mises reduced stress in slide-out protection groove (nonlinear elastoplastic calculations): a)  $r = 0.2$  mm, b)  $r = 4$  mm

The FEM [20] calculations indicate that at the bottom of the groove with radius  $r = 0.2$  mm stresses considerably exceed the yield point. The stresses come down below the yield point at radius  $r = 4$  mm.

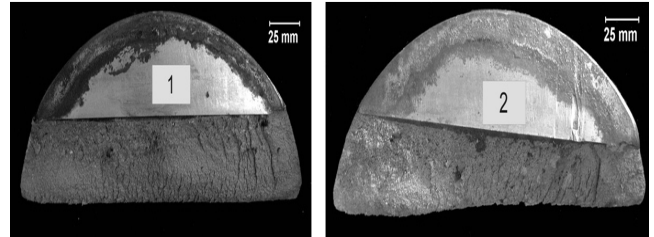
Fig. 13. Fragments broken off caterpillar halfshaft – element 1 and 2

The macroscopic examinations showed fractures originating in the caterpillar half-shaft. The fractographic investigations showed that the fractures had fatigue fracture features, including a temporary coarse-grained brittle zone (figs 15 and 16). In element 1 the fatigue zone area is located near edge AC and it takes up about 2% of the fracture area. The fatigue zone area in element 2 is located near edge EG, occupying about 4% of the fracture area (fig. 14). The fractures were locally coated with corrosion products. The fatigue zones have a lenticular shape, most wide close to the middle of edges AC and EG in the investigated elements [13 and 17]. The places are denoted as S1 and S2 for respectively elements 1 and 2. The fatigue zone in point S1 is about 3 mm wide against the temporary zone width of about 65 mm while in point S2 it is about 6 mm wide against the temporary zone width of about 60 mm (fig. 15). In the case of element 1, the first fatigue zone area is located by edge A and the second one at a distance of about 20 mm from edge C. Similarly in element 2 one fracture fatigue zone area is located directly at edge E while

the other at a distance of about 10 mm from edge G. Such a fatigue fracture structure indicates that the largest stresses occur in the medial part of the groove towards points A and C (element 1) and E and G (element 2).

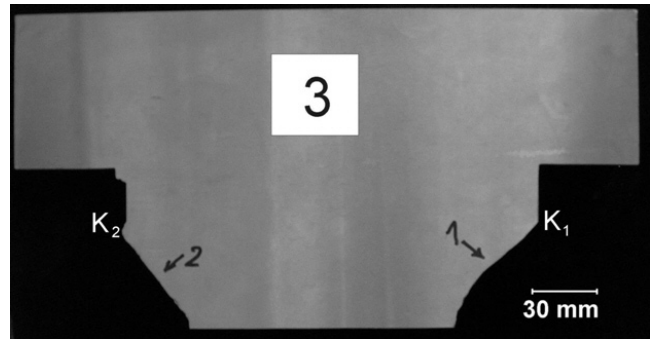
Fig. 14. Piece cut out from damaged halfshaft cross section – element 3

It was found that both fractures had been initiated at the place where the cross section changes. The fatigue zone is located along the undercuts denoted by symbols K1 and K2 in fig. 14. The fracture of element 1 ran parallel to edge AC and at an angle of 45 deg. to the halfshaft's longitudinal symmetry axis by edge GH. The angle gradually increases towards edge EF, reaching 60 deg.. This indicates that in element 1 the fracture of the half-shaft groove resulted from the action of shearing forces and bending moments on it. As a result of damage to element 1 an additional bending moment was produced (as one point of support was removed) whereby the direction of fracture propagation changed in element 2, as evidenced by the clear plastic deformation in point G, which probably occurred in the final stage of fracturing (fig. 16).

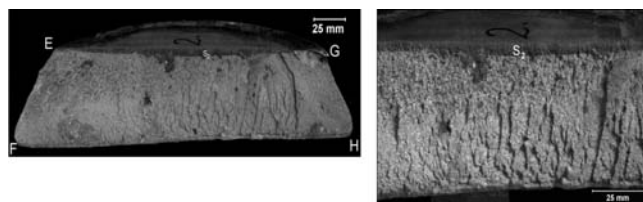
Fig. 15. General view of surface of fracture with marked edges. Symbol S2 marks widest fracture fatigue zone area

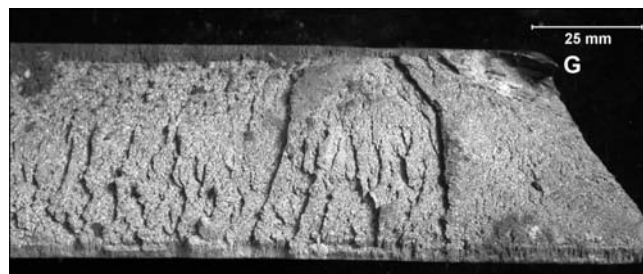
Fig. 16. Element 2. Magnified fragment from fig. 15 (visible plastic deformation in point G)

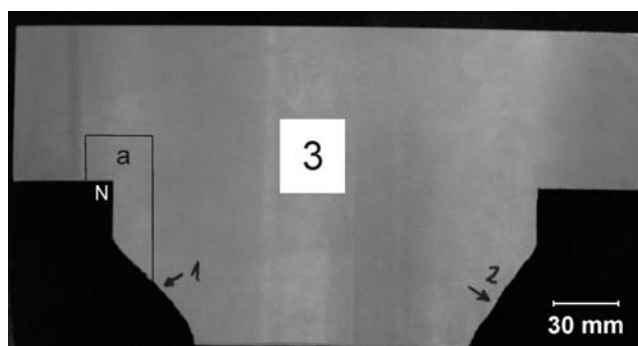
surface pressures were distributed on the groove's circumference and not over its whole surface. This distribution of clamping stresses explains the lenticular shape of the fatigue zone: since the clamping forces are uniformly distributed on the circumference, the maximum bending moments produced by them occurred in the groove's middle part in the region of points S1 and S2. The place from which the specimens were taken is shown in fig. 17.

Fig. 17. Place (determined by macroscopic examinations) where specimens for further metallographic studies were taken

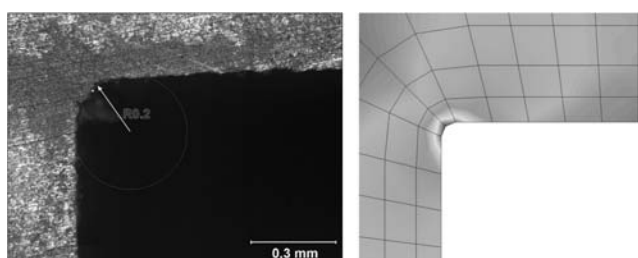
On both sides of specimen a the radius on the edge of the halfshaft groove for sliding in the protective plates was measured in the place marked N in fig. 17. A transition with curvature radius  $r=0.2$  mm was found. This radius is too small to be a manufacturing radius.

Fig. 18. Location of halfshaft groove; a) groove edge curvature radius  $r = 0.2$  mm on specimen's left side, b) plastic strain zone on groove's bottom

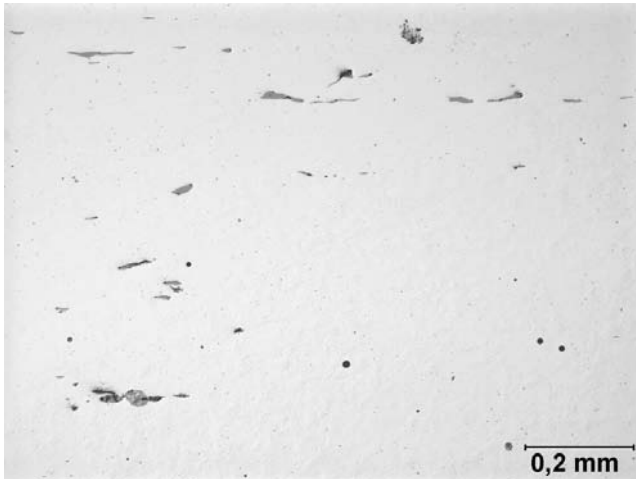
Microscopic examinations were carried out on unetched and etched (with Mi1Fe re-agents) microsections. The results of the examinations are shown as microphotographs in figs 19-22. In the unetched microsections non-metallic inclusions, mainly in the form of sulphides uniformly distributed over the whole surface of the specimen along the direction of plastic forming (fig. 19), were found.

Fig. 19. Non-metallic inclusions uniformly distributed over whole surface of micro-section along direction of plastic working. Unetched condition. Light microscopy

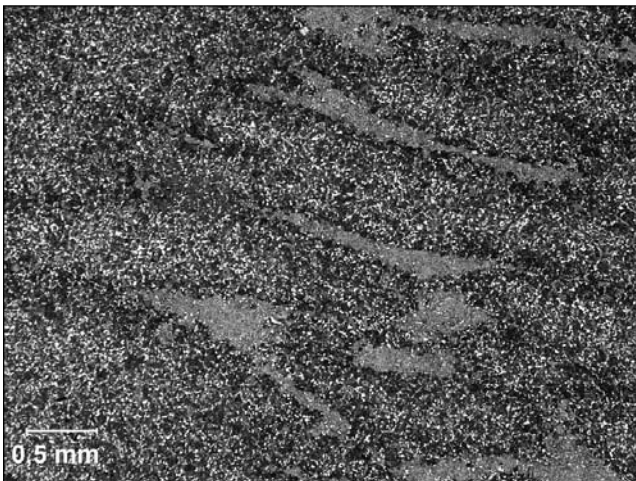
Fig. 20. Inhomogeneous pearlitic-ferritic structure. Etched condition. Light microscopy

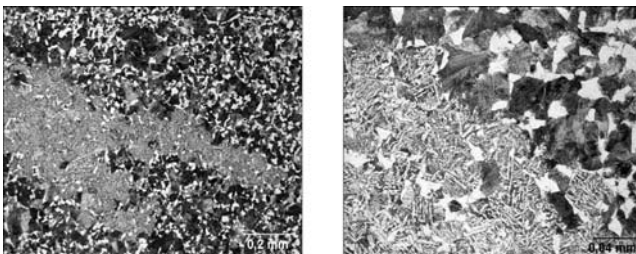
After etching with Mi1Fe a pearlitic-ferritic structure (locally in the form of the Widmanstätten structure) was observed (fig 21). Such a microstructure is the result of local inhomogeneity in chemical composition, caused by improper heat treatment and plastic forming and incomplete reforging of the steel because of the considerable thickness of the component. Consequently, the material's mechanical properties might have deteriorated [16]. The examinations also showed a crack originating from the groove's edge, running parallel to the cross section change edge at

Fig. 21. Etched condition. Light microscopy: a) inhomogeneous pearlitic-ferritic microstructure with features of Widmanstätten structure, b) magnified fragment

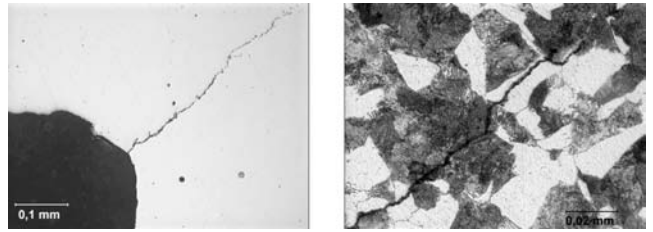
an angle of 45deg to the shaft's axis and running along the boundaries of ferrite and pearlite grains (fig. 22).

Fig. 22. Edge of lock groove. Light microscopy: a) visible crack initiated in area where cross section changes – unetched condition, b) magnified fragment of area in etched condition, visible crack running along boundaries of ferrite and pearlite grains
