Half-shaft undercarriage systems – designing and operating problems

Purpose: The paper discuss designing and operating problems of half-shafts undercarriage systems of open pit machines. Example of failure of such system and investigation of its reasons are presented.

Findings: It was found that manufacturing and designing of the half shaft system were the main failure reasons. Such open pit machines undercarriages systems are prone to failures. Detailed analyses are required to implement half – shaft systems without risk of break-down. Recommendation is given in the paper for the single shaft system.

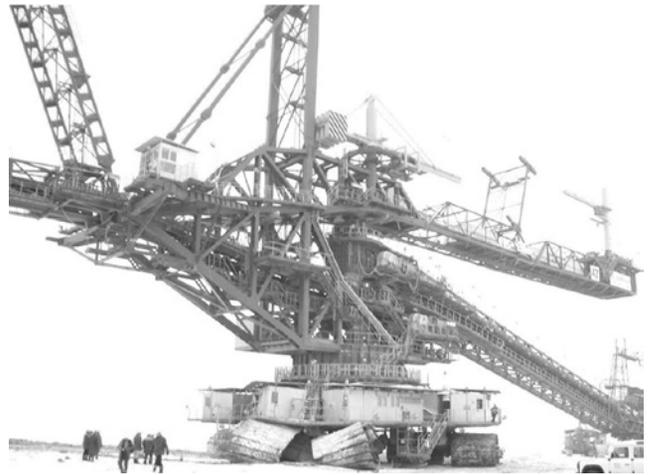
The overburden which is to be removed from an open pit being mined is transported to dumping conveyor which distributes it on the dump. The dumping conveyor's steerable carriage (Fig. 3) broke down during work in winter conditions. The dumping conveyor's driving system consists of one steerable and two nonsteerable caterpillar units. The steerable caterpillar unit is made up of two crawler frames, a carriage and a steering frame. A schematic of the steerable caterpillar unit is shown in Fig. 4.

Fig. 3. Breakdown of dumping conveyor's steerable carriage

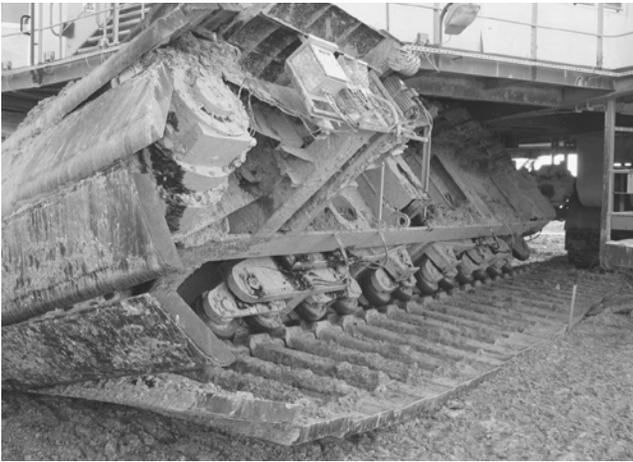
Due to damage of half shaft safetying one half-shaft slipped out and caused breakdown of the machine. The track girder of the dumping conveyor after the breakdown is shown in Fig. 6.

Fig. 6. Breakdown of one carriage: results of steerable carriage breakdown

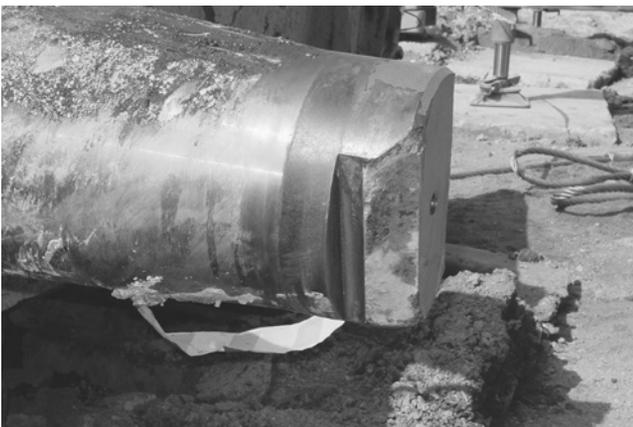
After the dumping conveyor's gantry together with the machine body had been hoisted and the track girder had been removed the damaged end of the halfshaft could be examined. The halfshaft's damaged end with broken off pieces is shown in Fig. 7.

Fig. 7. Damaged halfshaft of steerable carriage

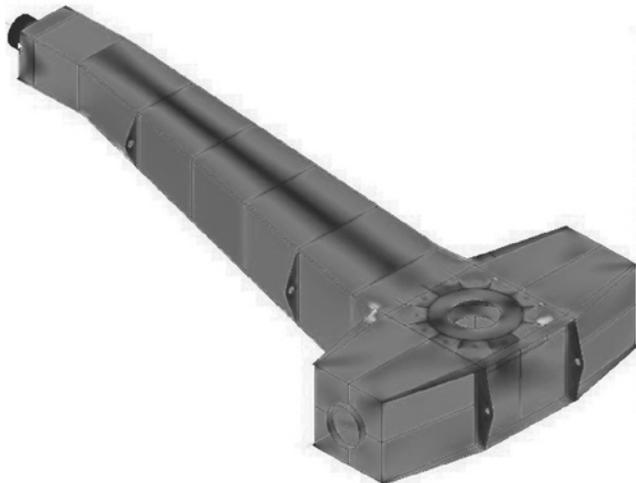
Fig. 9. Distribution of Huber - Misses stress in dumping conveyor's steering carriage

For all the required cases of loading no stress levels specified by the standard [1] were found to be exceeded. High stresses were observed only in the vertical ribs of the halfshaft's housing.

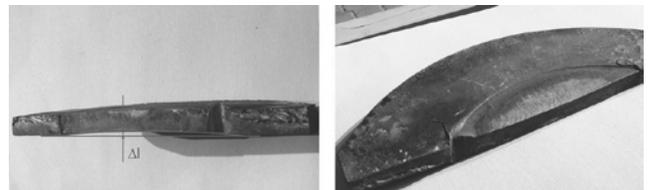
The plates protecting the halfshaft against slip out were deformed (Fig. 11) as a result of the longitudinal movement of the halfshaft .

Fig. 11. Deformed elements (plates) protecting against halfshaft slip out

Due to the axial clearance of the halfshaft static friction $\mu = 0.09-0.14$ becomes sliding friction $\mu = 0.01-0.05$. One should note that in this case sliding friction should not occur, but it did occur as evidenced by the deformation of the protective plates (Fig. 11). FEM calculations of the halfshaft end were carried out for the most unfavourable case of loading. One should note that because of the very small rounding radius at the bottom of the groove for the protective plates considerable stress concentrations arise under the action of axial forces. The radius is as small as $r = 0.2$ mm (as measured on microsections of the protection). The halfshafts were made of toughened constructional alloy steel 42CrMoS4 whose yield point is $Re = 880$ N/mm² and strength $Rm = 1030$ N/mm². The FEM strength calculations of the halfshaft were performed for two values of the axial force acting on the halfshaft protection: - axial force $F = 1393$ kN – the axial force at travelling along a curvature with radius $R = 60$ m with the terrain gradient and wind pressure (HZS (L)) taken into account and with neglected friction ($\mu = 0$) on the halfshaft mounting hubs, - axial force $F = 704$ kN – the axial force at travelling along a curvature with radius $R = 60$ m with terrain gradient and wind pressure (HZS (L)) and friction ($\mu = 0.09$) on the halfshaft mounting hubs taken into account.

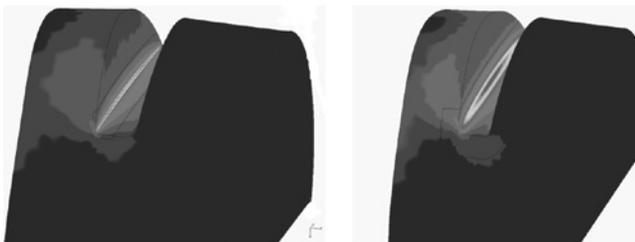
Figure 12 shows the distribution of Huber-Mises stress determined by FEM calculations [20] for radius $r = 0.2$ mm and $r = 4$ mm while the maximum Huber-Mises stresses on the groove's bottom for two values of the axial force transmitted by the halfshaft lug are given in Table 1. The rounding radius of 4 mm was adopted for comparison purposes in order to determine its safe (strength wise) value.

Fig. 12. Distribution of Huber-Mises reduced stress in slide-out protection groove (nonlinear elastoplastic calculations): a) $r = 0.2$ mm, b) $r = 4$ mm

The FEM [11] calculations indicate that at the bottom of the groove with radius $r = 0.2$ mm stresses considerably exceed the yield point. The stresses come down below the yield point at radius $r = 4$ mm.

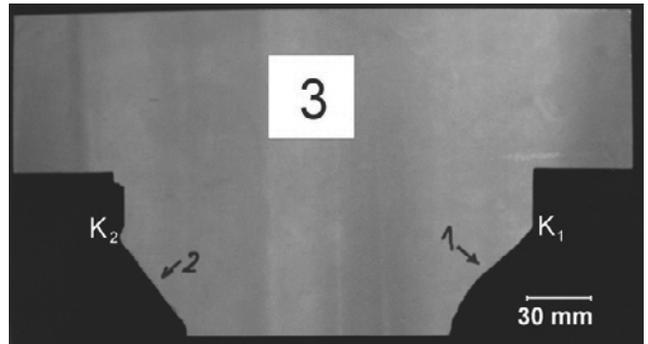
Fig. 14. Piece cut out from damaged halfshaft cross section – element 3

It was found that both fractures had been initiated at the place where the cross section changes. The fatigue zone is located along the undercuts denoted by symbols K1 and K2 in Fig. 14. The fracture of element 1 ran parallel to edge AC and at an angle of 45 deg. to the halfshaft's longitudinal symmetry axis by edge GH. The angle gradually increases to-wards edge EF, reaching 60 deg.. This indicates that in element 1 the fracture of the half-shaft groove resulted from the action of shearing forces and bending moments on it. As a result of damage to element 1 an additional bending moment was produced (as one point of support was removed) whereby the direction of fracture propagation changed in element 2, as evidenced by the clear plastic deformation in point G, which probably occurred in the final stage of fracturing (Fig. 16).

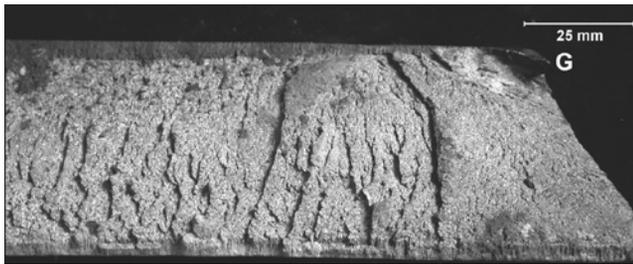
Fig. 16. Element 2. Magnified fragment from Fig. 15 (visible plastic deformation in point G)

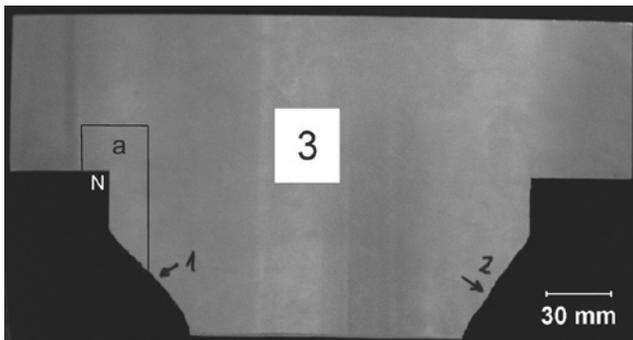
Fig. 17. Place (determined by macroscopic examinations) where specimens for further metallographic studies were taken

The signs of wear on the clamping surfaces indicate that the surface pressures were distributed on the groove's circumference and not over its whole surface. This distribution of clamping stresses explains the lenticular shape of the fatigue zone: since the clamping forces are uniformly distributed on the circumference, the maximum bending moments produced by them occurred in the groove's middle part in the region of points S1 and S2. The place from which the specimens were taken is shown in Fig. 17.

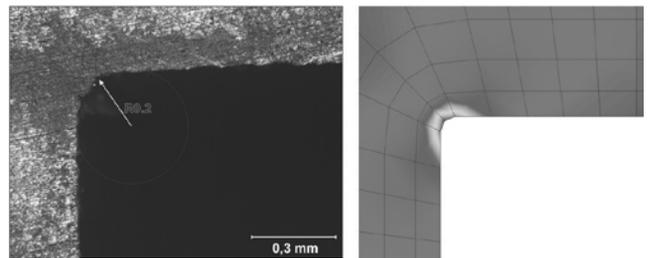
On both sides of specimen a the radius on the edge of the halfshaft groove for sliding in the protective plates was measured in the place marked N in Fig. 18. A transition with curvature radius $r=0.2$ mm was found. This radius is too small to be a manufacturing radius.

Fig. 18. Location of halfshaft groove; a) groove edge curvature radius $r = 0.2$ mm on specimen's left side, b) plastic strain zone on groove's bottom

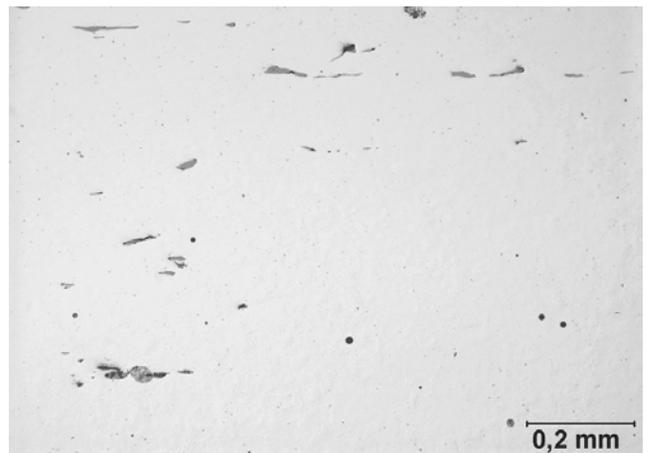
In the unetched microsections non-metallic inclusions, mainly in the form of sulphides uniformly distributed over the whole surface of the specimen along the direction of plastic forming (Fig. 19), were found.

Fig. 19. Non-metallic inclusions uniformly distributed over whole surface of micro-section along direction of plastic working. Unetched condition. Light microscopy

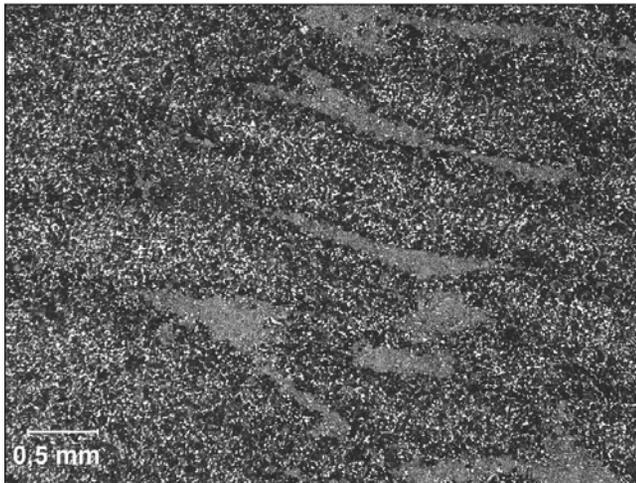
Fig. 20. Inhomogeneous pearlitic-ferritic structure. Etched condition. Light micro-copy

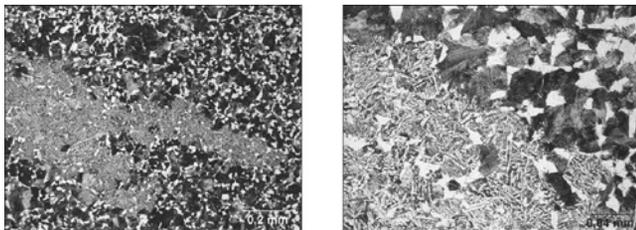
After etching with Mi1Fe a pearlitic-ferritic structure (locally in the form of the Widmanstätten structure) was observed (Fig. 21).

Such a microstructure is the result of local inhomogeneity in chemical composition, caused by improper heat treatment and plastic forming and incomplete reforging of the steel because of the considerable thickness of the component. Consequently, the material's mechanical properties might have deteriorated [15].

Fig. 21. Etched condition. Light microscopy: a) inhomogeneous pearlitic-ferritic microstructure with features of Widmanstätten structure, b) magnified fragment

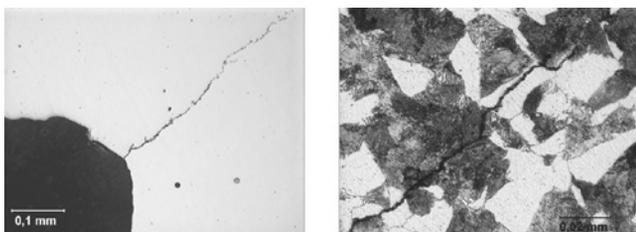
The examinations also showed a crack originating from the groove's edge, running parallel to the cross section change edge at an angle of 45deg to the shaft's axis and running along the boundaries of ferrite and pearlite grains (Fig. 22).

Fig. 22. Edge of lock groove. Light microscopy: a) visible crack initiated in area where cross section changes – unetched condition, b) magnified fragment of area in etched condition, visible crack running along boundaries of ferrite and pearlite grains

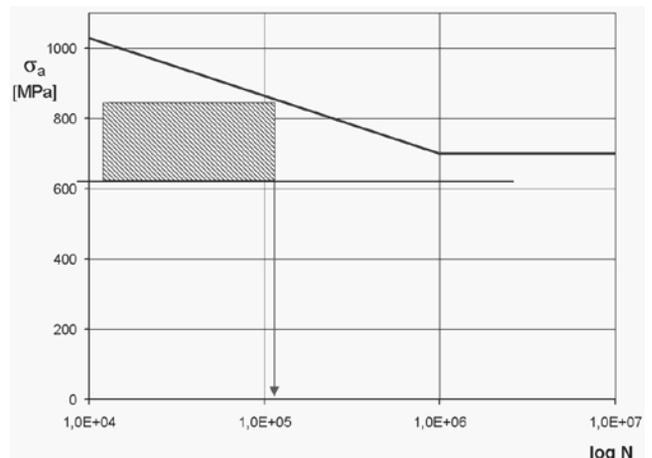
Fig. 23. Wöhler diagram for steel 40HM with marked limited fatigue strength region for radius $r = 0.2$ mm in halfshaft grooves

Due to the low ratio of fatigue zone area to remaining zone area a considerable effort of the structure or the use of very low safety factors could have been the case. Pearlitic-ferritic structure with locally occurring Widmanstätten structure was observed in the investigated element. These features might have resulted in the deterioration of the material's mechanical properties. Such a structure indicates that the element was not properly heat treated. Microscopic examinations of element 3 revealed the presence of cracks (Fig. 21) indicating the onset of fatigue fracture. The cracks were initiated at the place at the groove's bottom where the cross section changes and they extend into the material at angle of about 45deg parallel to the whole edge of the specimen taken from the element. The examinations showed that the slip-out protection had not been properly designed and made. The direct cause of the breakdown was the too small rounding radius of the groove's bottom ($r = 0.2$), leading to fracture, sliding out of the halfshaft and the breakdown of the dumping conveyor. A fatigue analysis of the groove's bottom showed that the halfshaft material was in the range of limited fatigue strength (Fig. 22). Hence it is concluded that the adopted protection is not good for this system of fixing the halfshafts. A much better solution is an annular protection with a properly large rounding radius of the halfshaft groove. The undercarriage system consisting of two

halfshafts is advantageous from the fabrication and weight points of view. An alternative could be a single-shaft design in which the slide-out protection is much simpler (vertical protection in the form of an additional shaft). But this system would be much heavier (hollow shafts could be employed to reduce the weight) and more expensive.
