Evaluation of microstructure and mechanical properties of a steam turbine casing after long-term service

Purpose: of this paper is to reveal the microstructural changes in Cr-Mo and Cr-Mo-V cast steels steel exposed to long-term service at elevated temperatures. The paper presents results of research and failure analysis undertaken to determine failure causes of a steam turbine casing. After 130,000 hours of service the crack in a outer shell of the turbine casing was found.

The casing has been a part of an action steam turbine type 13UP55 with nominal power 55 MW with steam working parameters 535°C/12.7 MPa. The turbine was made by Zamech Elblag, Poland. The turboset has been exposed to service for 130,000 hrs at a Heat and Power Plant. During a periodic inspection the crack in the outer shell (upper part) of the turbine casing was found. The crack was transverse to the turbine axis, and had 700 mm in length and 19 mm in depth. Thickness of the casing in the crack vicinity was 90-100 mm. The outer shell of the casing was made of cast steel grade G20CrMo4-5 (older Polish grade L20HM), while the inner shell of grade G21CrMoV5-7 (L21HMF). The crack was removed by grinding and the c

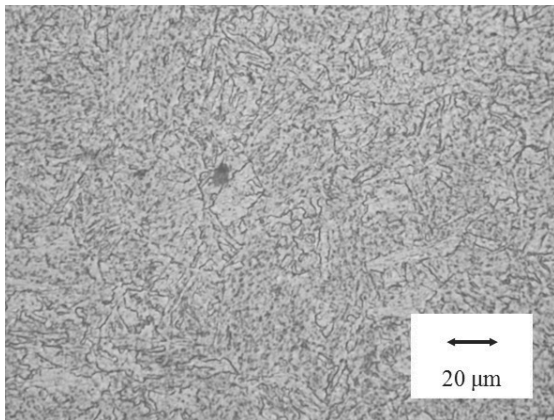
Microstructure of the samples taken from inner shell of the casing (made of G21CrMoV5-7) composes of tempered martensite (Figs. 1-3). It indicates that the inner shell was quenched and tempered. The level of microstructure degradation (changes in microstructure resulting from long-term impact of temperature and stress in service) is low.

Fig. 1. Microstructure of inner shell of the casing made of G21CrMoV5-7, nital etched, LM

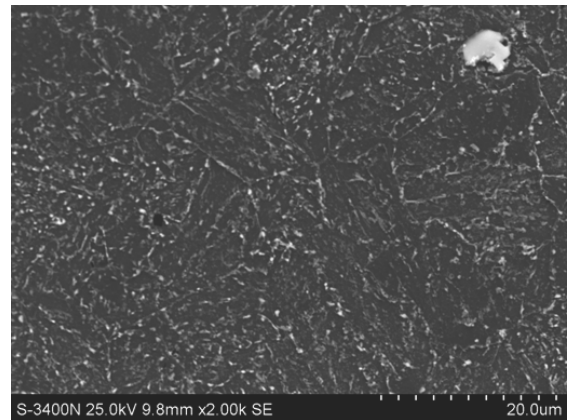
Fig. 3. Microstructure of inner shell of the casing made of G21CrMoV5-7. Carbon extraction replica, SEM

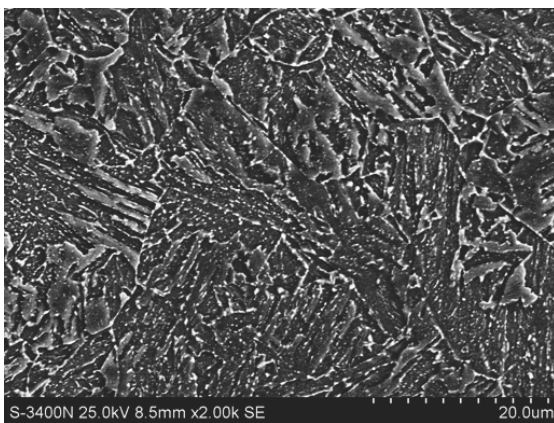
Fig. 2. Microstructure of inner shell of the casing made of G21CrMoV5-7. Cross section, nital etched, SEM

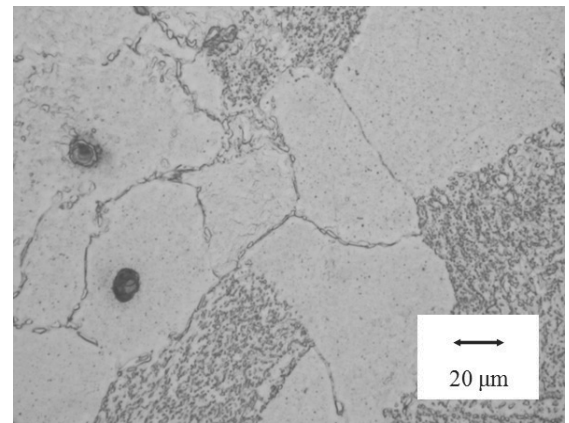
Microstructure of the samples taken from outer shell of the casing (made of G20CrMo4-5) composes of tempered ferrite and bainite/perlite (Figs. 4-6). It indicates that the inner shell was annealed - normalized and stress relieved. The level of microstructure degradation is intermediate. Metallographic examinations revealed changes in microstructure, i.e. partial decomposition of bainite/perlite along with carbides precipitation on ferrite grain boundaries. No evidences of creep failure in the form of voids were observed. Many big nonmetallic inclusions were found in the outer shell of the casing (Fig. 7). The diameter of the nonmetallic inclusions was as high as 100-200 μm. Chemical composition of the inclusion presented in Fig. 7 was determined with the use of EDS spectrometer. The inclusion is composed of complex oxides of iron, aluminum, titanium, silicon, with cesium, lanthanum, and potassium (Figs. 8-9). The origin of it is from the casting process.

Fig. 4. Microstructure of outer shell of the casing made of G20CrMo4-5. Nital etched, LM

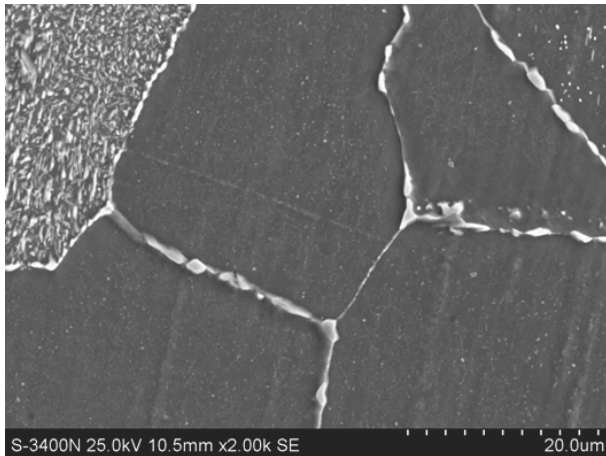
Fig. 5. Microstructure of outer shell of the casing made of G20CrMo4-5. Cross section, nital etched, SEM

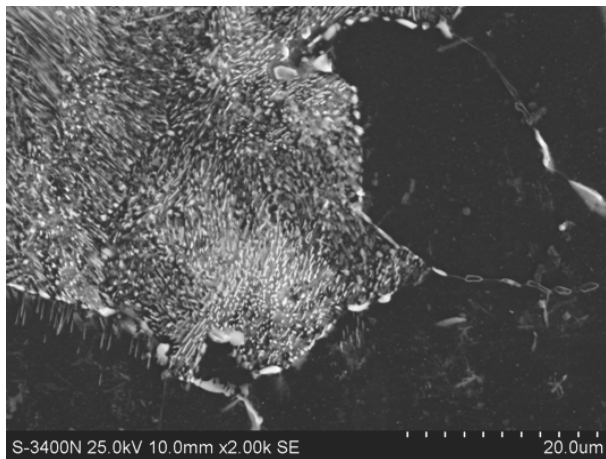
Fig. 6. Microstructure of outer shell of the casing made of G20CrMo4-5, carbon extraction replica, SEM

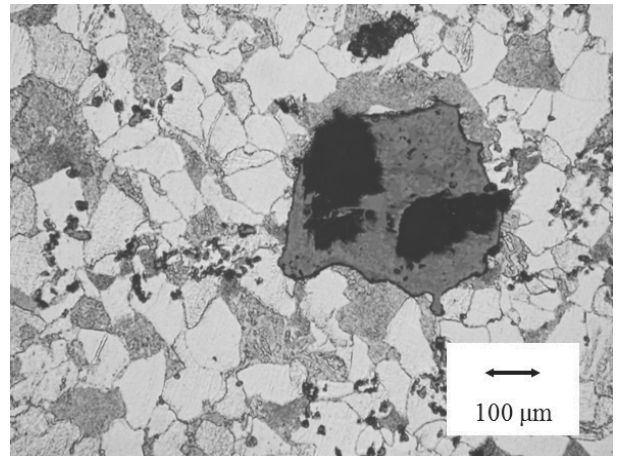
Fig. 7. Microstructure of outer shell of the casing made of G20CrMo4-5 with big nonmetallic inclusion, nital etched, LM

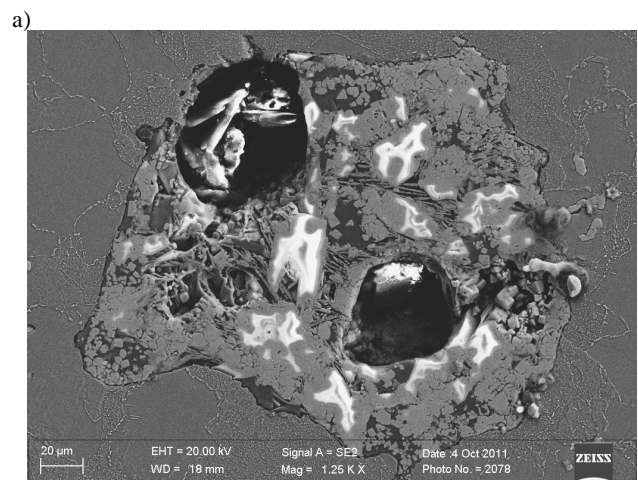
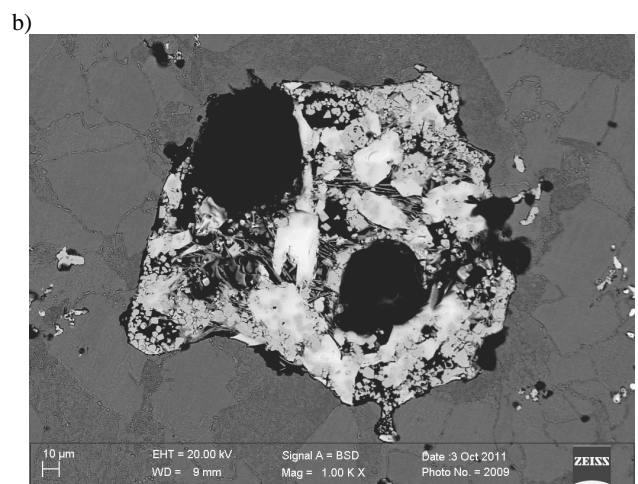
Fig. 8. Nonmetallic inclusion in outer shell of the casing made of G20CrMo4-5, SEM with detector: a) SE; b) BSE

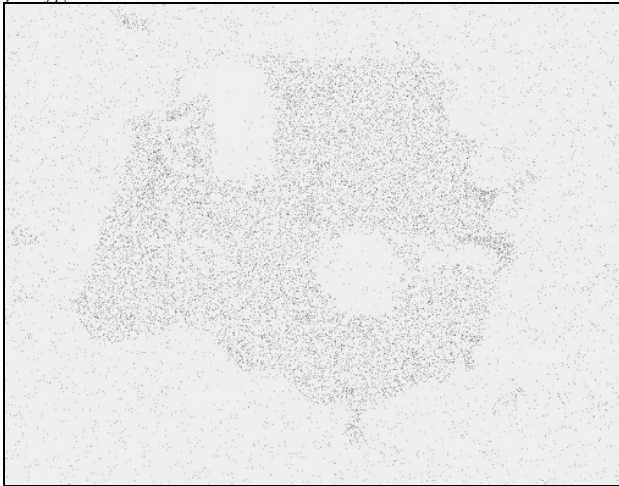
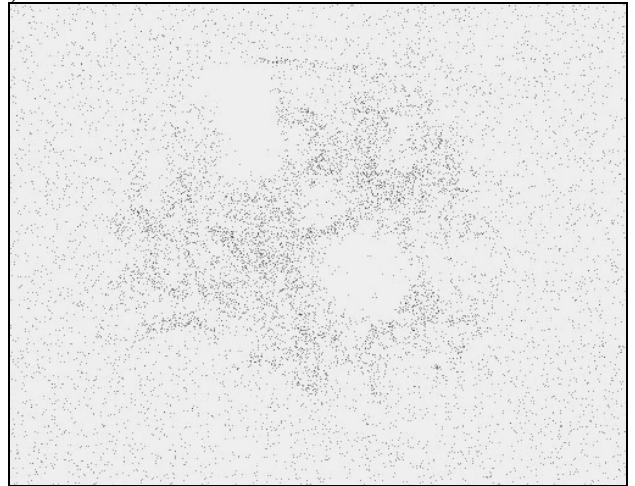
Fig. 9. Elements concentrations in nonmetallic inclusion presented in Fig. 8. SEM-EDS X-ray mapping

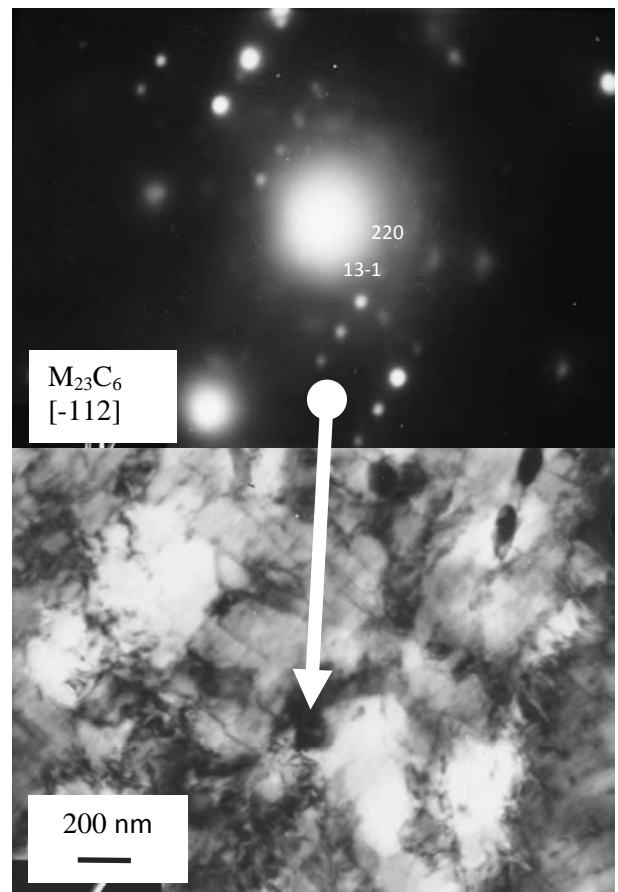
TEM examinations revealed the presence of the following components of microstructure. The inner casing microstructure composed of tempered lath martensite with fine precipitations of MC type carbides. At martensite lath borders M_3C type carbides were observed. At subgrain borders and inside subgrains $M_{23}C_6$ type carbides were found (Fig. 10). The outer casing microstructure consisted ferrite and perlite/bainite. At ferrite grain borders coarsened M_3C and $M_{23}C_6$ carbides were identified. Inside perlite/bainite grains coarsened plate-like M_3C carbides and spheroided $M_{23}C_6$ carbides were presented. Additionally, fine needle-like M_2C type carbides were observed (Fig. 11), which indicates that microstructure degradation process of the outer casing is more advanced.

Fig. 10. Microstructure of inner shell of the casing made of G21CrMoV5-7, thin foil, TEM

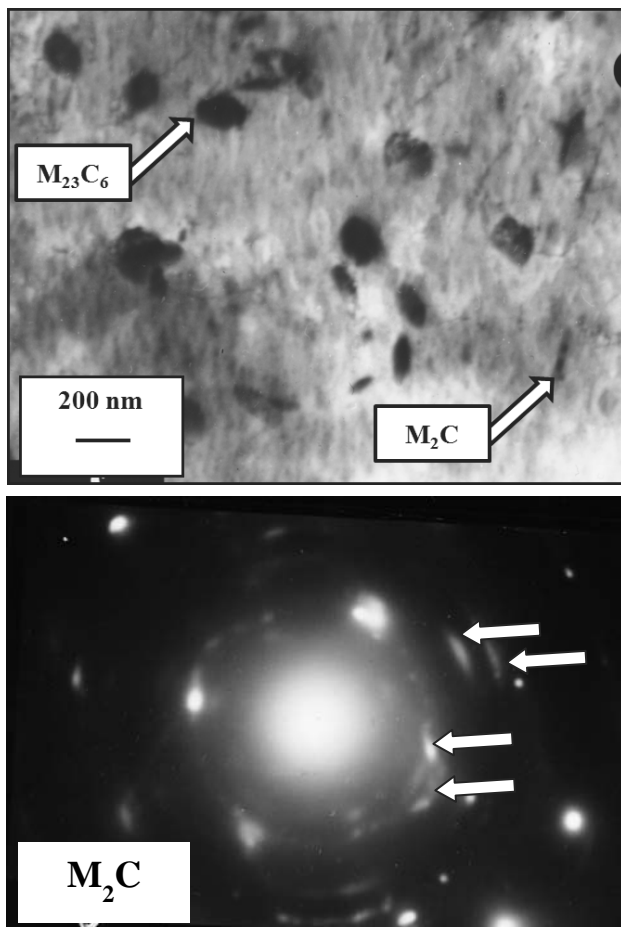
Fig. 11. Microstructure of outer shell of the casing made of G20CrMo4-5, thin foil, TEM

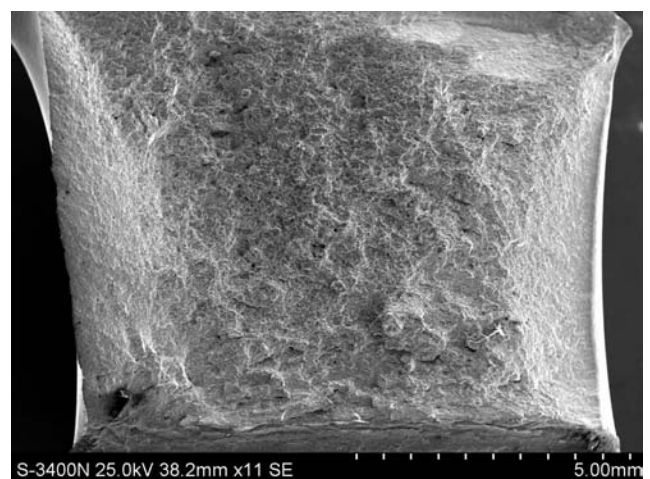
confirm good toughness of inner shell of the casing with microvoid coalescence mode of fracture (Figs. 12-13). High brittleness of outer shell of the casing is confirmed by transgranular cleavage mode of fracture (Figs. 14-15).

Fig. 12. Macroscopic view of fracture surface of the Charpy sample. Inner shell of the casing made of G21CrMoV5-7, SEM

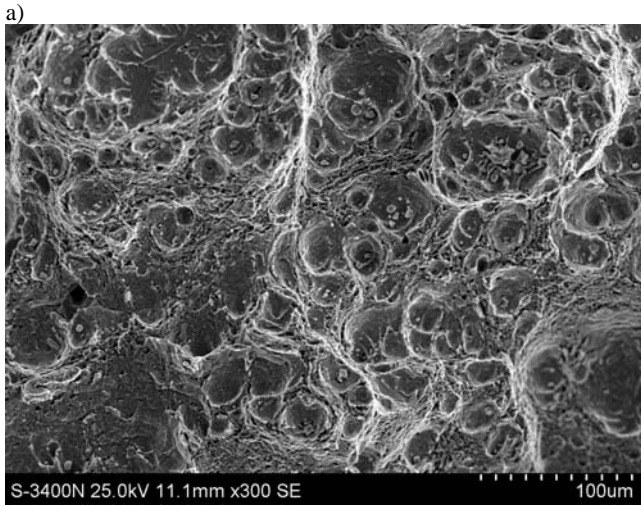
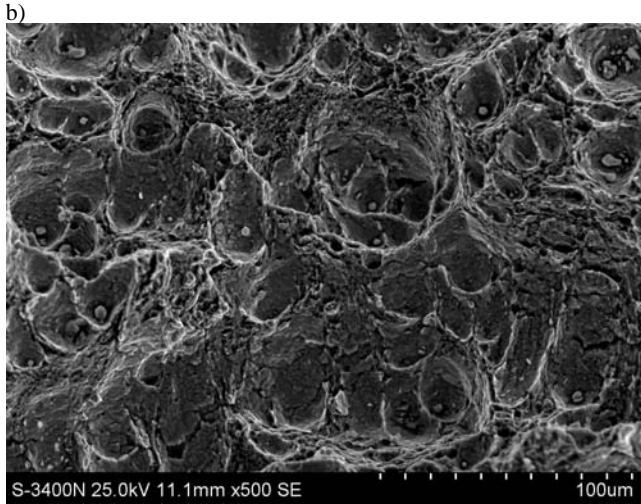
Fig. 13. Microscopic view of fracture surface of the Charpy sample. Inner shell of the casing made of G21CrMoV5-7, SEM

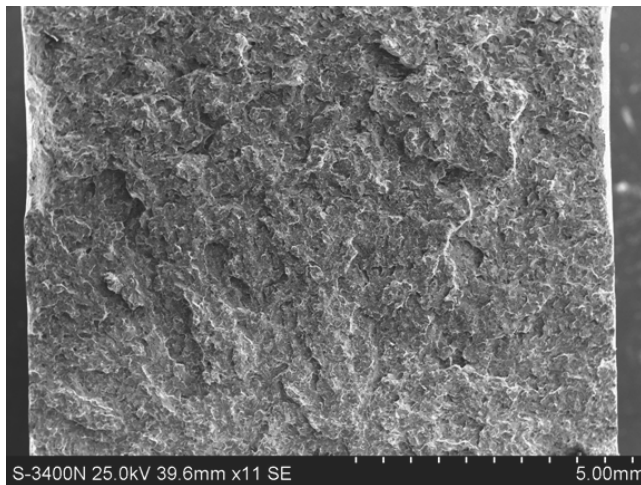
Fig. 14. Macroscopic view of fracture surface of the Charpy sample. Outer shell of the casing made of G20CrMo4-5, SEM

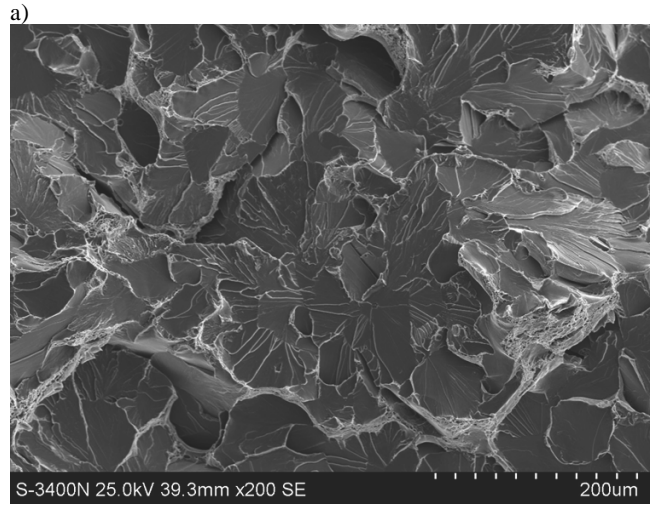
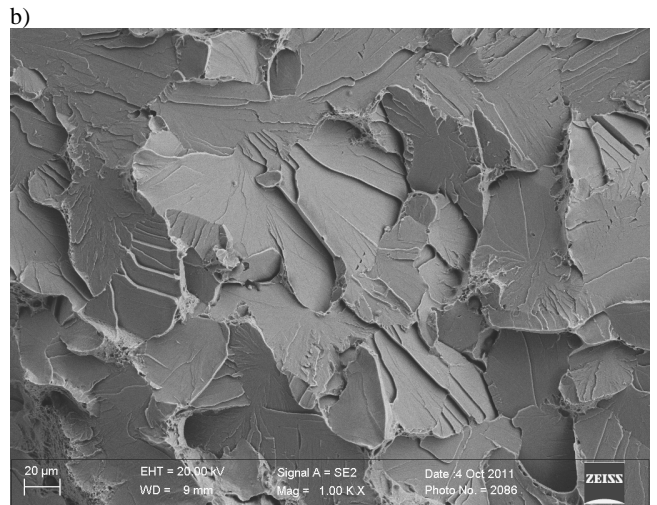
Fig. 15. Microscopic view of fracture surface of the Charpy sample. Outer shell of the casing made of G20CrMo4-5, SEM
