## Failure of austenitic stainless steel tubes during steam generator operation

**Purpose:** of this study is to analyze the causes of premature failure of steam generator coil made of austenitic stainless steel. Special attention is paid to corrosion damage processes within the welded joints.

The steam generator studied worked with a nominal pressure of 12-16 bar, under outlet steam temperature 160°C. The working time of the device was 6 months, with numerous intermissions in service. The reason for the withdrawal of the generator from the operation was leaks in the coil tube caused by corrosion damage.

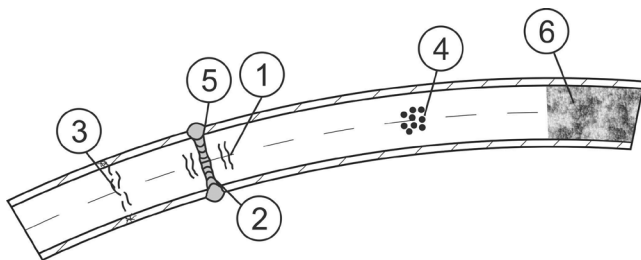
Inspection and macroscopic observations of the internal and external surfaces of the coil pipe segments revealed circumferential cracks, clusters of small pits, a single topical water spills and significant corrosion damage in the areas of welded joints. Discolored outer surface of the pipe was detected in the form of rusty and very dark coatings. The inner surfaces of tubes were covered with a fairly thick layer of deposits with different color and morphology. The color of deposits was significantly different, from light rust to a very dark, almost black. Figure 1 shows schematically the defect types at observed steam coil pipe.

Fig. 1. The observed damages of the steam coil pipe: 1 - circumferential cracks in the HAZ, 2 - depressions, cracks and voids in the root of the weld, 3 - cracks in the areas of stress concentration, 4 - clusters of pits, 5 - corrosion on welding joints defects, 6 - a thick layer of deposits

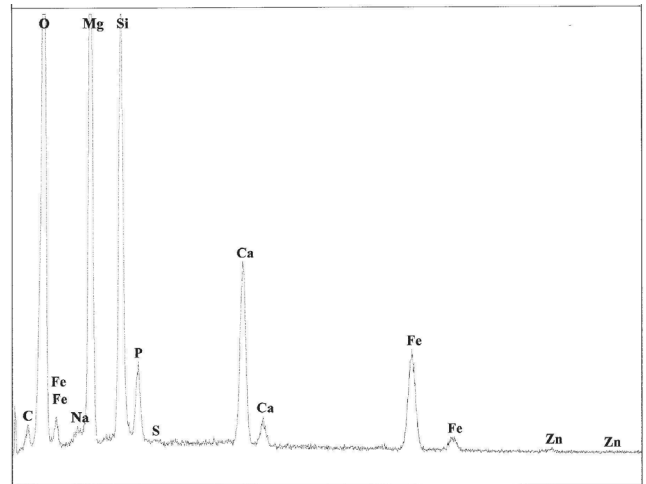
Fig. 2. The results of microanalysis of deposit

The high concentration of Mg and Ca ions in the deposits indicates that water quality monitoring and its treatment was insufficient. Sparingly soluble carbonates and sulphates of calcium and magnesium formed a hard and porous layer called boiler scale. Excessive deposition of minerals, due to disorders of the boiler water composition has a significant influence on the temperature of the pipe wall, which can be overheated (up to 500-600°C) and can deform, which accelerates the initiation of cracks and corrosion processes [2,19]. Corrosion processes are accelerated by water penetrating into the sediment and producing superheated steam. In such conditions all salts can evolve out of the water, even these very soluble, then react with the metal ground and form corrosion products [11,12]. Examples of deposit corrosion as deep pits in the tube wall are shown in Fig. 3.

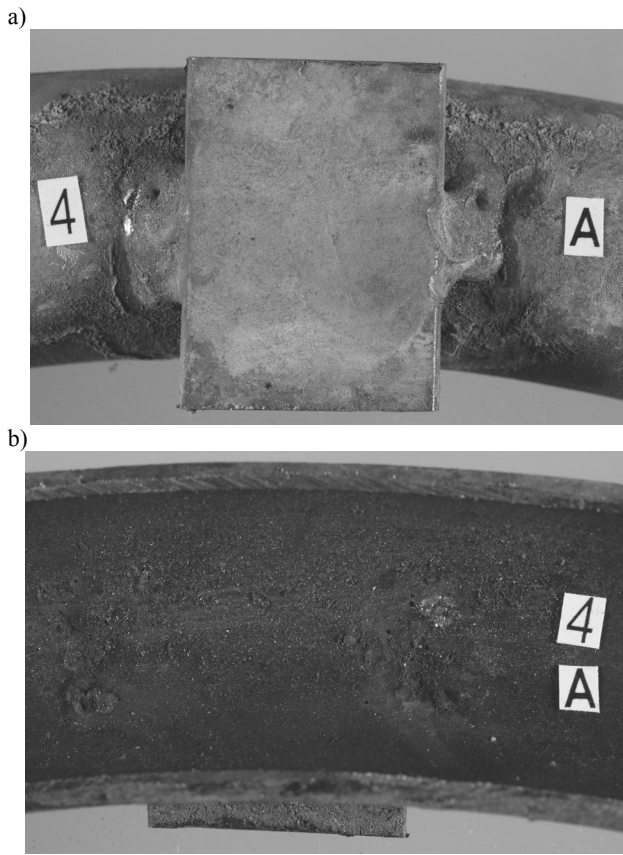
Intense pitting corrosion was also found on the inner surface of pipes under welds connecting coil stiffeners. Figure 7 b clearly shows two pitted areas under the welded joints where the inner surface of the pipe is heated to high temperatures.

Fig. 7. Stiffener welded to the pipe coil, a) outer surface, b) the inner surface attacked by pitting corrosion

- Avoid excessive stiffening of the tubes. Welding of the coils stiffeners should be performed with minimal heat input.
- It is advised to apply stress relief annealing after cold bending of the tubes to remove internal stresses.
- Cleaning the inner surfaces of the coil tube surface passivation of the surface should be performed after welding.
- Water quality monitoring. Keep the feed water pollution at the appropriate level.
- Flooding of the evaporator tubes with water or completely remove water and drain installation at each stopping installation.
- Procedures for the periodic removal of scale in the coils should be supplemented by passivation of the pipe.

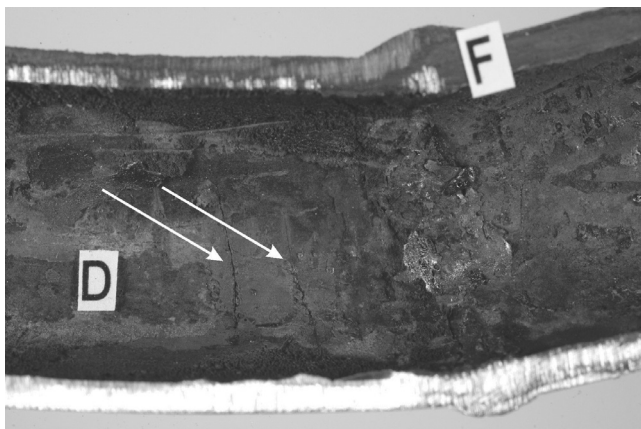
Many cracks were observed in the welded joints area. These cracks propagated parallel to the joints at heat affected zone Fig. 8.

Fig. 8. Cracks in the HAZ of the circumferential weld

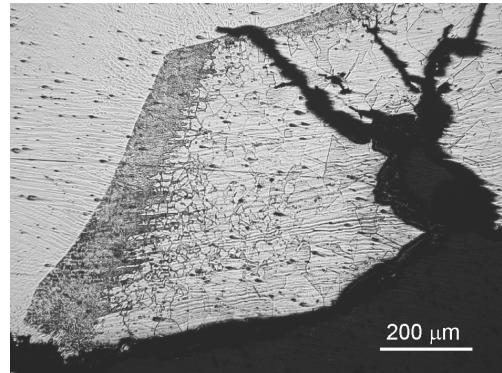
Initiation of cracks come from the inside of the pipe. Metallographic examination of pipe wall sections showed that crack initiated in the HAZ propagate in different directions and the development of cracks in some cases has been blocked and changed direction at the fusion line. Figure 9 shows crack of considerable thickness, it is associated with subsequent reactions inside the crevices and electrochemical dissolution of cracks walls.

Fig. 9. The propagation of cracks initiated by intergranular corrosion

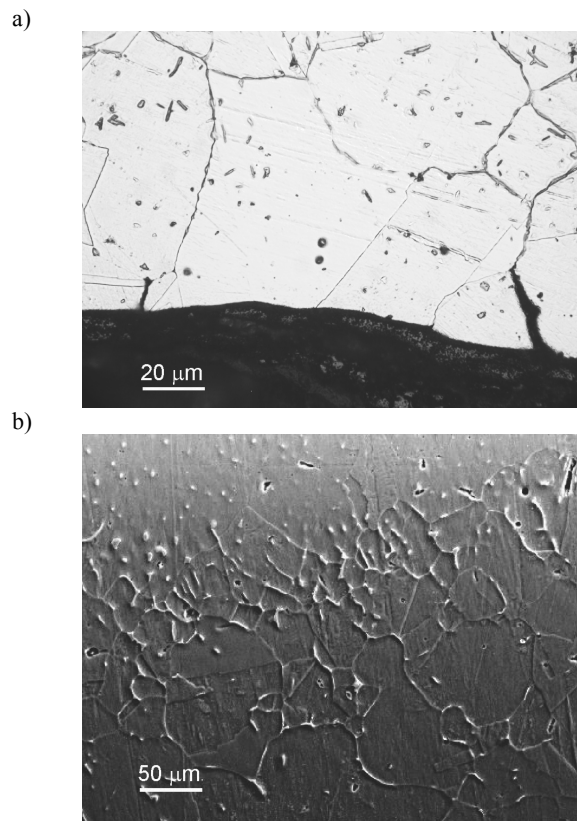
Fig. 10. The structure of sensitized zone of austenitic stainless steel, a) light microscope image, b) SEM image - visible carbides net at grain boundaries of austenite

A detailed analysis of cracks showed their intergranular propagation along the austenite grain boundaries which were decorated by chromium carbide precipitates. Figure 10 shows the microstructure of sensitized HAZ zone, with clearly visible coagulated carbides located mainly at the austenite grain boundaries, forming an almost continuous net. Such a distribution of carbides in the HAZ was also observed by scanning electron microscope, Fig.10 b. This was confirmed by EDX field qualitative analysis of the chromium distribution and is direct evidence of steel sensitization in the HAZ area where the temperature reached 500 to 800°C.

- In order to avoid intergranular corrosion austenitic steels with a carbon content below 0.02% should be selected instead of steel stabilized with Ti or Nb, which does not fully protect against such corrosion.
