Background of branched crack formation in surface zone of continuously-cast Ti-Nb microalloyed steel slab

Purpose: This work deals with the study of the background to the formation of branched cracks in a continuously-cast slab, at pulling rate $0.43 \text{ m}\cdot\text{min}^{-1}$.

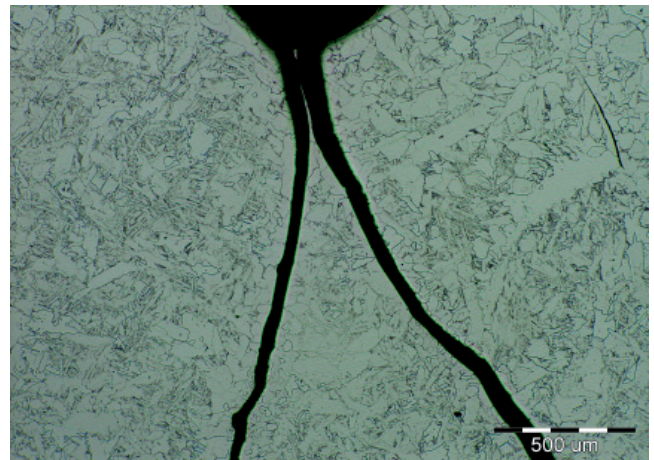
with central cut-out B, and they ranged deeper below the slab surface. Microstructural analysis showed heterogeneity in the ferrite grain size in the surface skin, as demonstrated in work [6]. The microstructure was mostly polyhedral ferritic-pearlitic. It was further demonstrated that tertiary cementite was present on the ferritic grain boundaries. The presence of cementite was confirmed by EDX analysis. It was present either in the form of small oval particles or in form of a network. In the marginal cut-outs in addition to polyhedral microstructure, non-equilibrium microstructure of acicular character was also observed, often in the area around the cracks (Fig. 3).

Fig. 3. Detail of branched crack below the OM

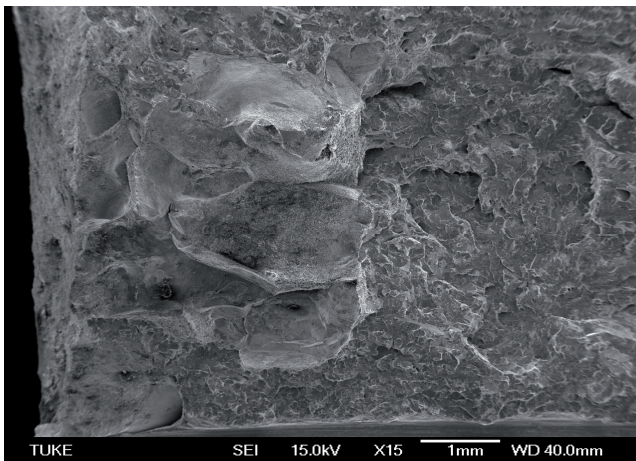
Fracture surfaces obtained by crack opening on samples taken from the surface skin were characterized by the presence of coarse intercrystalline facets (Fig. 4) in the surface skin, which ranged in depth to max. 7 mm below the slab surface. These facets were mostly covered with an oxide layer. Dimples of ductile intercrystalline failure (DIF) were located on these facets. A close-up of facets showing ductile intercrystalline failure with dimples (DIF) is provided in Fig. 5. Areas were sometimes also observed in the surface skin where melting of steel occurred. Particles observed in this area were mostly based on Fe, Mn, S with small amounts of Ti, C and Al.

Fig. 4. Coarse intercrystalline facets in the surface skin

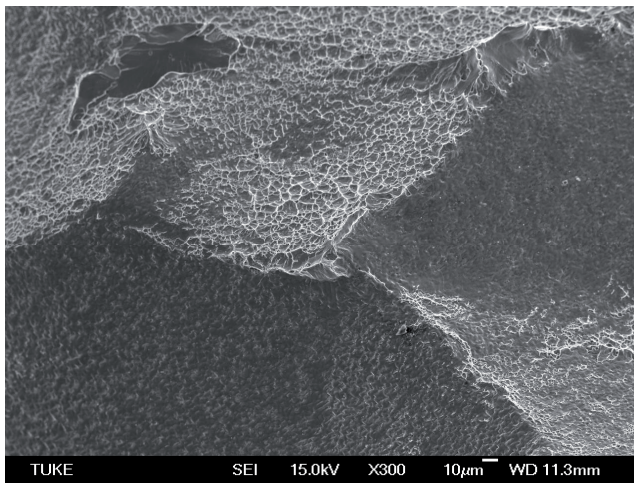
Fig. 5. Detail of DIF with dimples

3. The fracture surfaces from crack opening below the surface skin showed the occurrence of coarse inter-crystalline facets, mostly covered with a layer of iron oxide. Dimples on these facets were very shallow, and EDX analysis confirmed the presence of particles at the bottom of these dimples, mainly of MnS type.

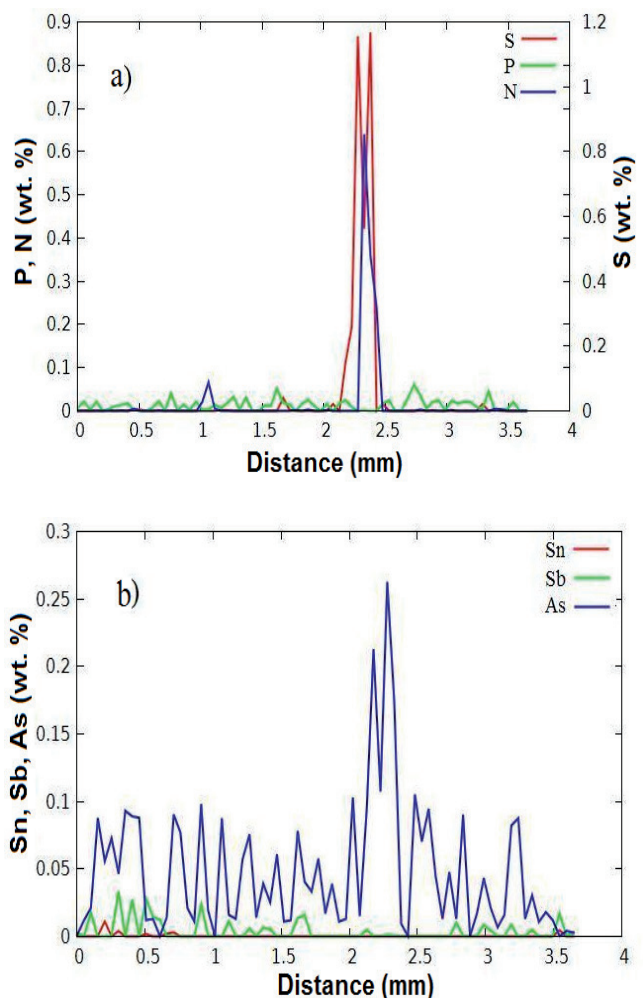
At the point of the crack below the deep OM on sample A36, the concentration profile of the selected components was determined using WDX analysis. The crack ranged in depth ~ 5.5 mm below the OM and concentrations of elements were determined at different depths according to the scheme in Figure 2. Figure 6a shows the distribution profiles of elements S, P and N in a plane parallel to the slab surface at a depth of 1 mm below the OM with cracks, where we can see high peaks of sulphur. This area was locally enriched with sulphur, and the max. peak of sulphur concentration reached 1.17%. In this area a high content of nitrogen was also confirmed, which had a max. peak value of 0.64%. Even higher nitrogen content (0.82%) was observed at 4 mm below the OM with cracks. The high content of nitrogen probably indicates the presence of precipitates based on nitrides. In Figure 6b distribution

profiles are shown of surface-active elements, namely Sn, Sb and As parallel to the slab surface at a depth of 1 mm below the OM. High content of arsenic was demonstrated, which amounted to max. concentration of 0.26%. Higher content of As was also observed at a depth of 8 mm and even at a depth of 12 mm below the OM, where max. concentrations were in the range 0.13 to 0.20% As. These high concentrations indicate significant segregation of this harmful surface-active element even deeper below the slab surface. The concentrations of the other two elements were lower compared with arsenic. Max. concentration of tin (0.088%) was found at a depth of 12 mm below the OM. Antimony had max. concentration of 0.074% at a depth of 12 mm below the OM.

Fig. 6. The spectra of WDX analysis show the varying concentration of components in a plane parallel to the slab surface at a depth of 1 mm below the OM with cracks: (a) S, P, N, (b) Sn, Sb, As

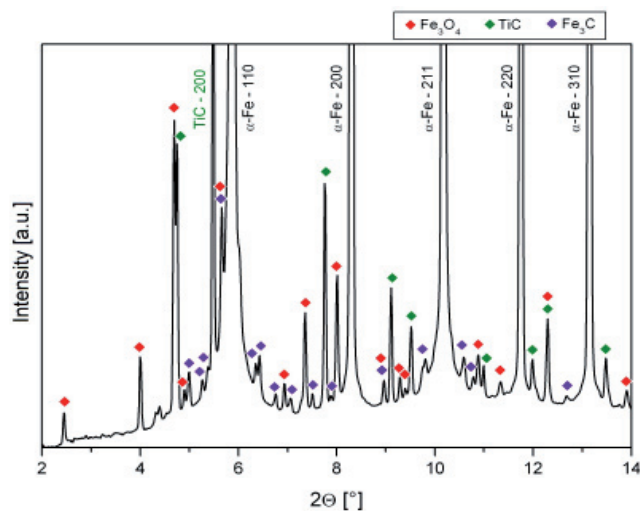
The method of hard X-ray diffraction using the PETRA III positron accelerator at HASYLAB / DESY in Hamburg, produced a diffraction pattern for the sample C12 with cracks which showed that the indexed reflecting planes belonged in the majority phase of α -Fe, while the minor phase was almost unidentifiable. In spite of the fact that the software did not identify the minor phase, the reflections are situated in the detailed diffraction records that are shown in Fig. 7. The record samples C12 identified a total of three secondary phases: Fe_3O_4 , TiC and Fe_3C .

Fig. 7. Detail of diffraction record of the sample C12 with cracks

precipitation with microalloying elements, resulting in an increased probability of surface crack formation. This is also confirmed in this work, because Fe_3C and also TiC were identified in sample C12 with cracks. Formation of branched cracks in the surface skin of the analyzed slabs made from Ti-Nb microalloyed steel is due to a combination of several factors, namely: lower pulling rate, local segregation of harmful impurities such as S and surface-active elements Sn, Sb, but mostly As. Another factor is the presence of brittle cementite network on the ferritic grain boundaries in combination with TiC .
