## A study of worn wear plates of fan blades of steel mill fumes suction system

A. Klimpel, D. Janicki

**Abstract:** In this paper, examination of a part of worn fan blade of the fan of steel mill fumes suction system are presented. Fan body was made from the CORTEN steel and the working surfaces of the blades are covered by wear plates 4666 CDP (4666 DP 0503) produced by CASTOLIN Co. It was proved that the main reason of very strong wear of the middle part of the fan blades is fumes erosion phenomenon greatly accelerated by water pollution of fumes.

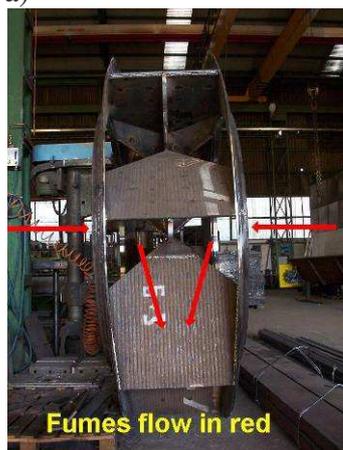
During fumes suction operation the fan blades are subjected very strong wear phenomena of erosion corrosion (mechanical erosion degradation augmented by corrosion) which result in very strong wear of the center part of the blade, Fig. 1a. Fumes produced during steel milling process ventilated by the suction system are polluted by water leakage from furnace cooling system. Water presence in fumes as a pollutant is the main source of atmospheric and galvanic corrosion which strongly augments fumes' erosion wear phenomenon. Atmospheric corrosion of fan blades is greatly accelerated by water (moisture) in fumes. The surface of the wear plate is attacked by atmospheric corrosion and as the result products of the corrosion in the form of oxides (rust) and sulphates are constantly produced on the fan blades wear plates surfaces and the surface of CORTEN steel fan body. Products of atmospheric corrosion are not erosion resistant in comparison to high chromium cast iron alloy deposit of the wear plates of blades, so these products are rapidly removed from the deposit surface what strongly accelerates fan blades wear [3, 4].

Figure 1. a) - a view of the fan of steel mill fumes suction system. Fan blades are covered by the wear plates 4666 CDP attached to the fan body by arc spot welding, b) - a view of worn center part of the fan blade

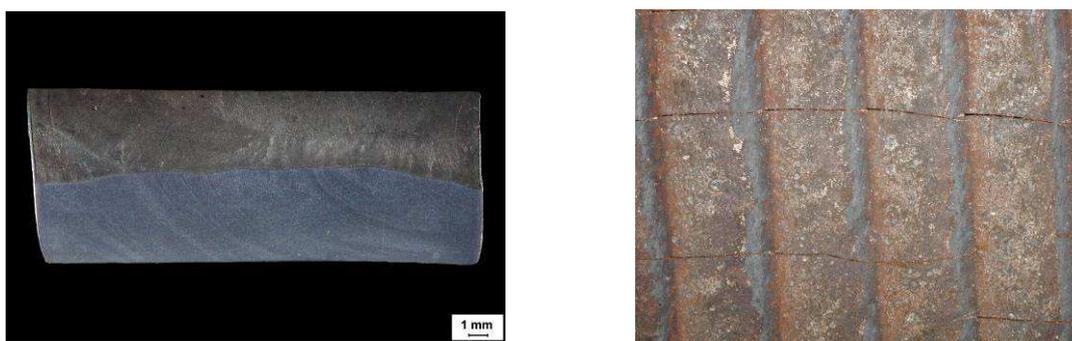
CORTEN steel fan body, shown in Fig. 3, Table 1 and 2. Less noble - anodic carbon steel base material of 4666 CDP and CORTEN steel fan body ( - 0,6 [V] to - 0,7[V] - standard potential) then cathodic high chromium base cast iron alloy of 4666 CDP deposit ( - 0,45 [V] to -0,50 [V]) are attacked to greater degree. As a result the 4666 CDP base material and CORTEN steel of the fan body are strongly dissolved and form ions which migrate from anodic areas of carbon steels on the surface into the electrolyte. Additionally galvanic corrosion initiates strong crevice corrosion in the area of fusion zone between deposit and base material of 4666 CDP, in the bottom area of the residual stresses cracks of the deposit, shown in Fig 2, which later continues as stress corrosion cracking.

Figure 2. Macrograph and a view of the surface of the wear plate 4666 CDP, visible transverse cracks induced by SSA surfacing residual stresses

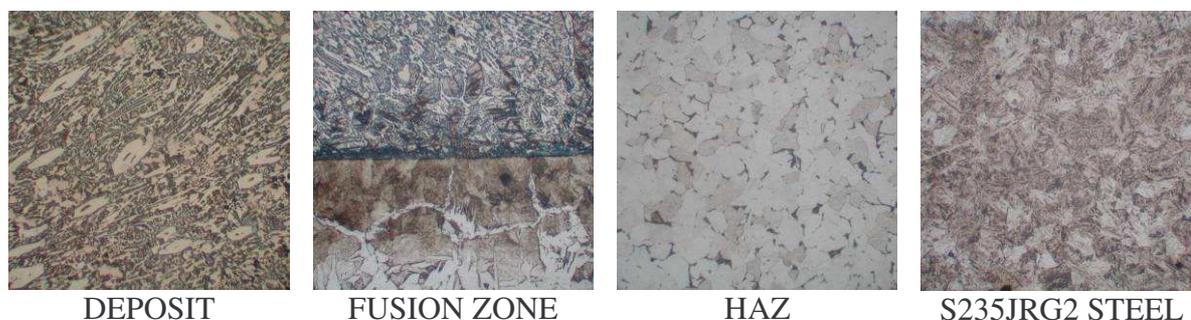
Figure 3. Micrograph of deposit, fusion zone, HAZ and base material of 4666 CDP, 200x magnification

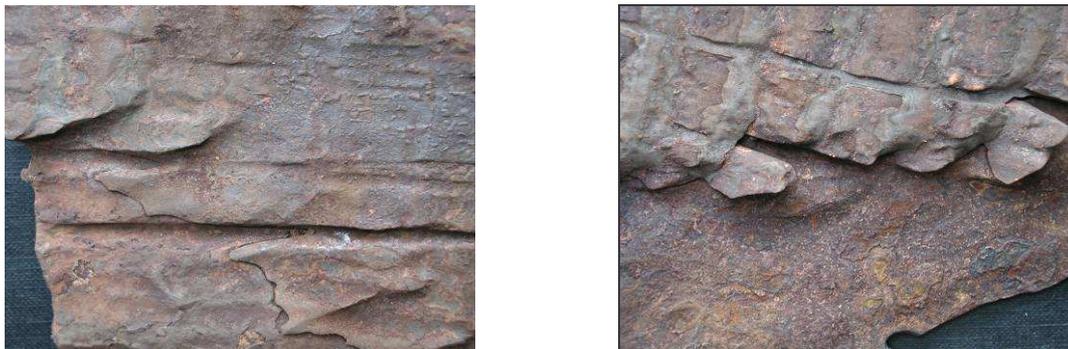
Figure 4. A view of strongly eroded, corroded and cracked surfaces of 4666 CDP deposit and CORTEN steel fan body, 2x magnification

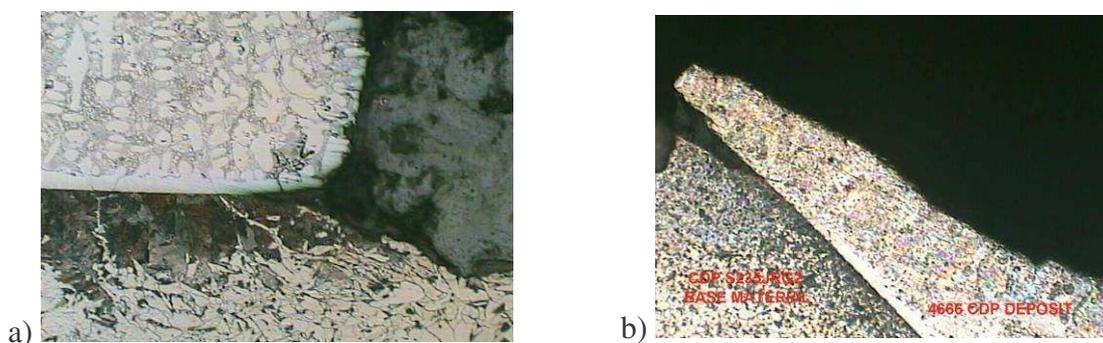
Figure 5. Micrograph of cracked and galvanic corrosion area of 4666 CDP deposit, showing galvanic corrosion crevice between deposit and base material; magnification: a) 200x, b) 100x

1. Basic compounds of the products of atmospheric corrosion of 4666 CDP deposit are  $Mn_3O_4$ ,  $Fe_2O_3$  and  $Cr_5O_{12}$  oxides and FeS troilite as a result of water pollution of fumes.
2. Basic compounds of the products of atmospheric corrosion of 4666 CDP deposit are  $Mn_3O_4$  and  $Fe_2O_3$  oxides and FeS troilite as a result of water pollution of fumes.
3. Visual and metallographic examination have proved that the main reason of very strong wear of the middle part of the fan blades, Fig. 1b, is fumes erosion phenomenon greatly accelerated by water pollution of fumes. Water pollution is the source of very strong atmospheric corrosion and galvanic corrosion of 4666 CDP and CORTEN steel fan body shown in Fig. 4 and Fig. 5.
4. Galvanic corrosion induced strong crevice corrosion and stress corrosion cracking of the 4666 CDP shown in Fig. 5.
