Effect of microstructural banding in hot-work tool steel on thermal expansion anisotropy

B. Pawłowski*, P. Bała, R. Dziurka, J. Krawczyk

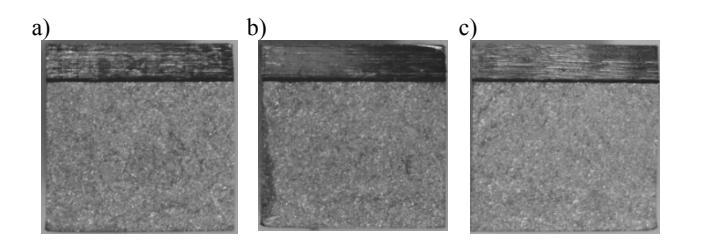
Fig. 5. The brittle fracture surface images of a Charpy specimens, a) XZ plane, b) YZ plane, c) XY plane

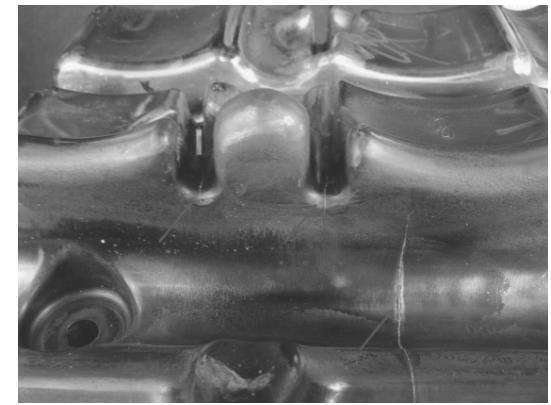
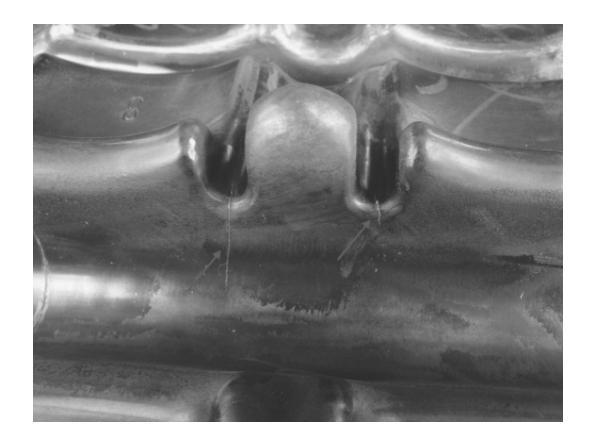
The parallel cracks, indicated by arrows, on working surface of die are presented in Fig. 6.

The number of surface cracks, presented in Fig. 6, were parallel to the X-axis; cracked working surface of the die is the XY-plane. For the metallography, macroscopic observation of etched (2% nital) were made and the light microscope Zeiss Axiovert 200MAT was used. As dilatometric test is the simplest way to predict thermal expansion anisotropy of steel, ultra high-resolution dilatometer RITA L78 was used to determine thermal expansion coefficients along to the three axes of the coordinate system. Dilatometric samples (\emptyset 3x10 mm rods) were heated to 600°C (injection temperature of aluminium alloys) at heating rate 0.05°C/s. Thermal expansion coefficients were determined in the temperature ranges 30 - 100°C, 30 - 200°C, 30 - 300°C, 30 - 400°C, 30 - 500°C and 30 - 600°C.

Fig. 6. Working surface of the investigated die, a) three parallel cracks, b) another cracks propagated along the same direction

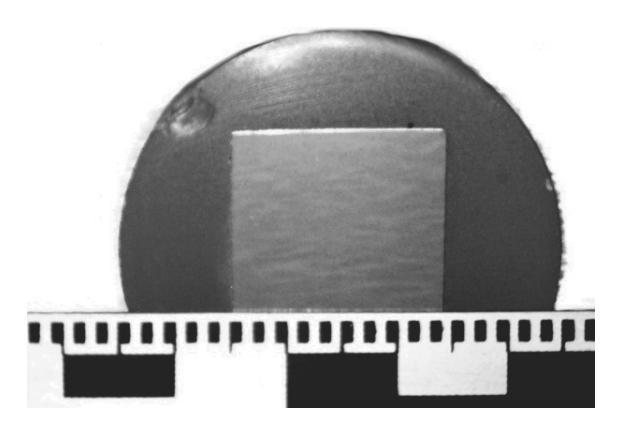
Macroscopic images presenting microstructural banding in investigated die are shown in Figs. 8-10. As it can be seen, bands direction is parallel to the X axis, which is also direction of crack propagation. In case of samples for metallographic observations using a light microscope, as it was mentioned above, the evidence of microstructural banding manifested in the small but clear etching differences, as it is presented in Figs. 11-13.

Fig. 8. Macroscopic image of microstructural banding in XZ plane (etched with 2% nital)

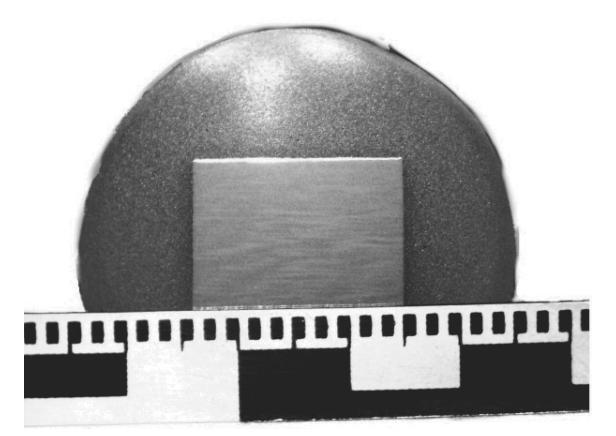
Fig. 9. Macroscopic image of microstructural banding in XY plane (etched with 2% nital)

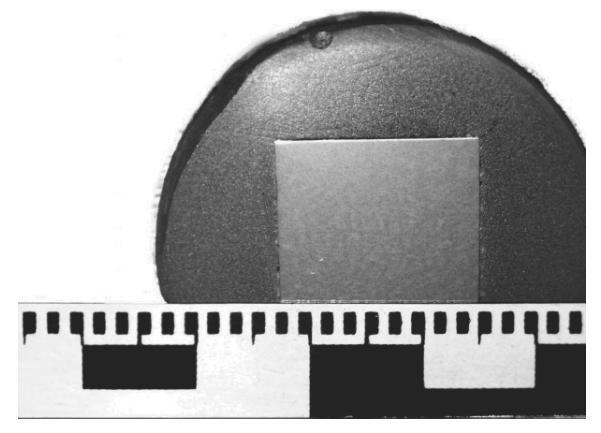
Fig. 10. Macroscopic image of microstructural banding in YZ plane (etched with 2% nital)

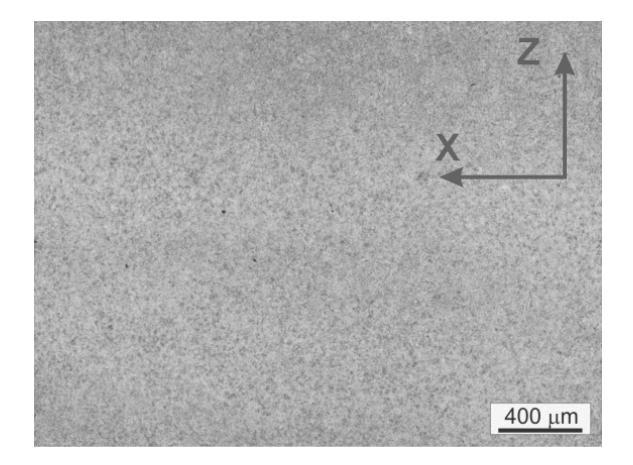
Fig. 11. Microstructure for the XZ plane (etched with 2% nital)

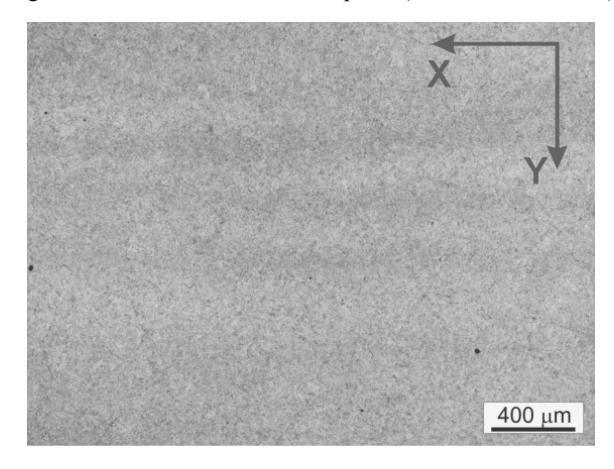
Fig. 12. Microstructure for the XY plane (etched with 2% nital)

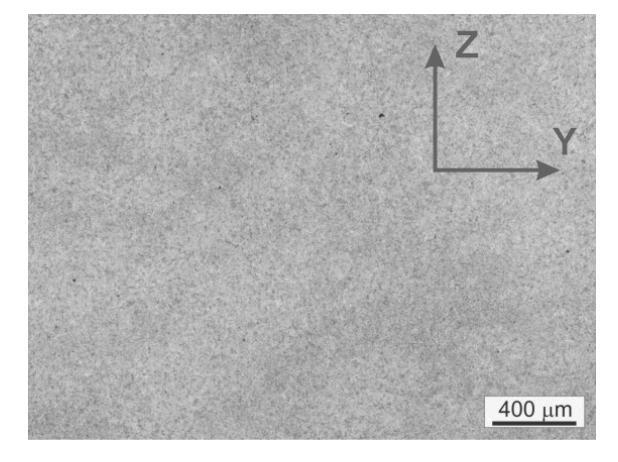
Fig. 13. Microstructure for the YZ plane (etched with 2% nital)

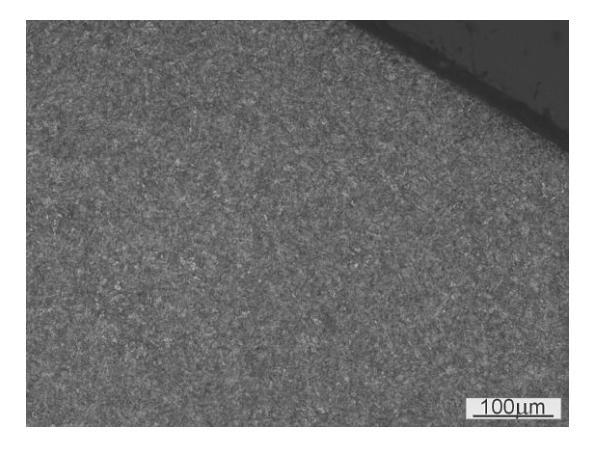
In the subsurface layer no decarburization regions and wear traces were observed, as it is presented in Fig. 15.

Fig. 15. Microstructure in the subsurface layer of investigated die (etched with 2% nital)

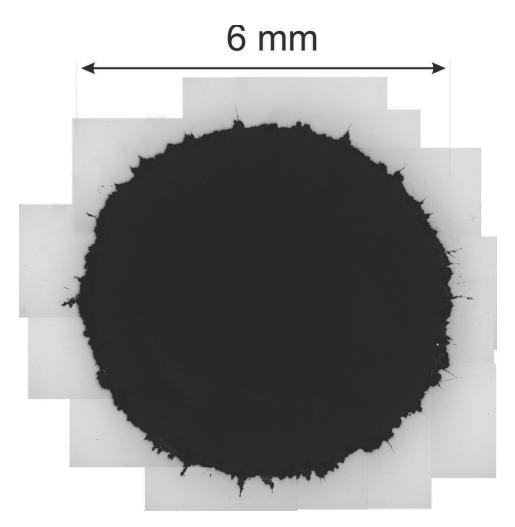
In present work, microscopic observation of the cooling hole cross-section (Fig. 17) revealed that around the edge of the hole many fine cracks have started.

Fig. 17. Cracks nucleation at edge of cooling hole

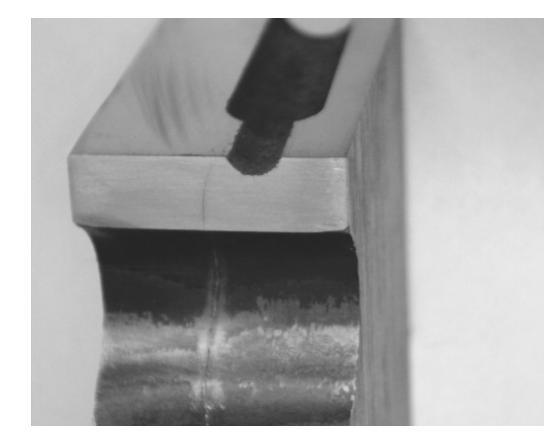
One of the surface cracks, presented in Fig. 6a, originated at edge of the cooling hole, as it is shown in Fig. 18.

Fig. 18. Propagation of crack originated at edge of cooling hole

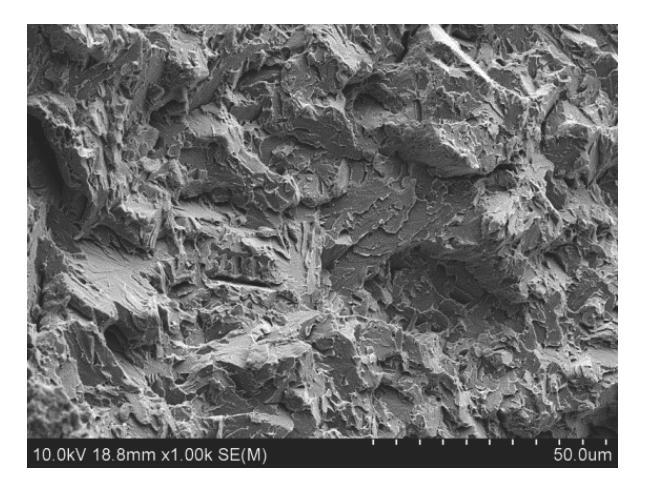
Die Casting Association standard [15] but could promote crack propagation, regardless of very low fracture toughness, as it was revealed in the work [11]. SEM studies by use of scanning electron microscope Hitachi SU-70 revealed brittle fracture mode of observed surface cracks, as it shown in Fig. 19.

Fig. 19. Brittle fracture mode of observed surface crack (SEM)
