Comparison of impact delaminations in CFRP using different test methods

I. Ehrlich ^a, H. Dinnebier ^{b,*}, C. Jost ^a

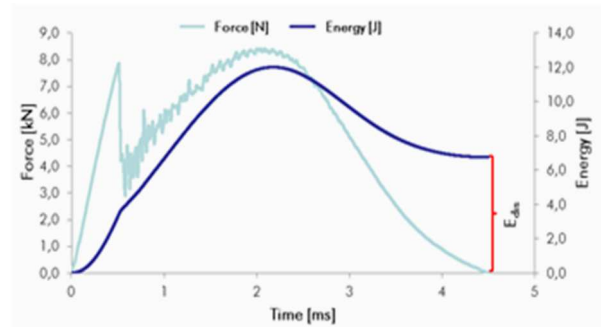
Fig. 2. Force vs. time and energy vs. time diagram. Constant impact height of $h=170\ \text{mm}$, impact velocity of $v=1.83\ \text{m/s}$ and impact mass of $m_{\text{imp}}=7.25\ \text{kg}$

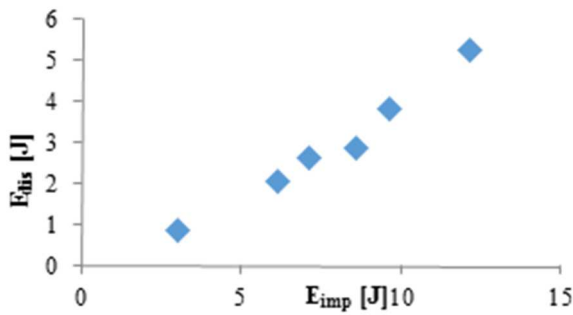
Fig. 3. Dissipative energy E_{dis} versus impact energy E_{imp} .

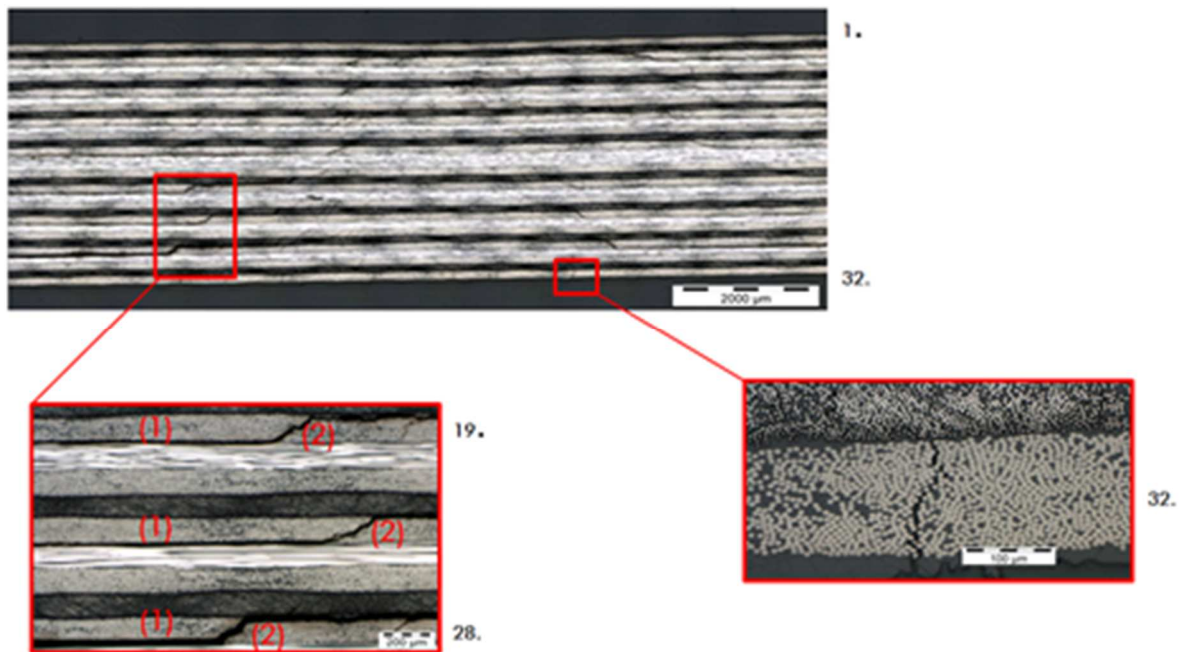
Fig. 5. Detailed view of a micrographic cross-section

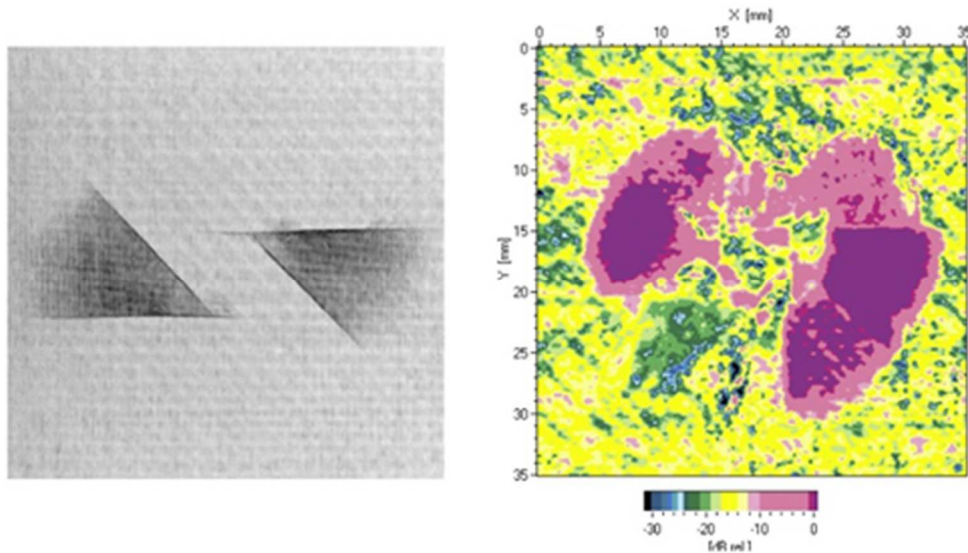
Fig. 6. μ CT thick slab picture of one delamination layer and ultrasonic picture of the same layer - .325 mm depth

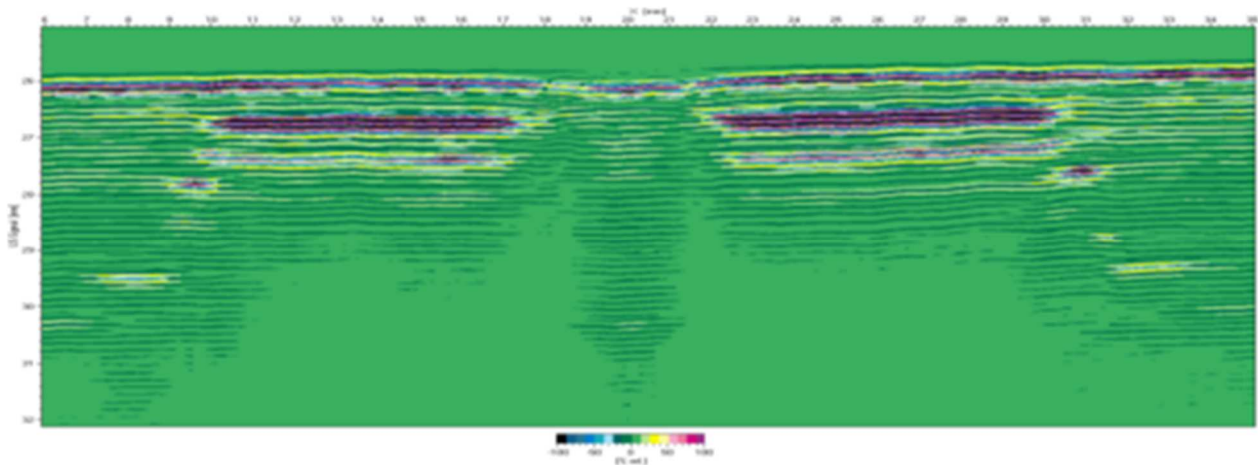
Fig. 7. UT B-Scan – The top delaminations are visible, the lower delamination only show up at the

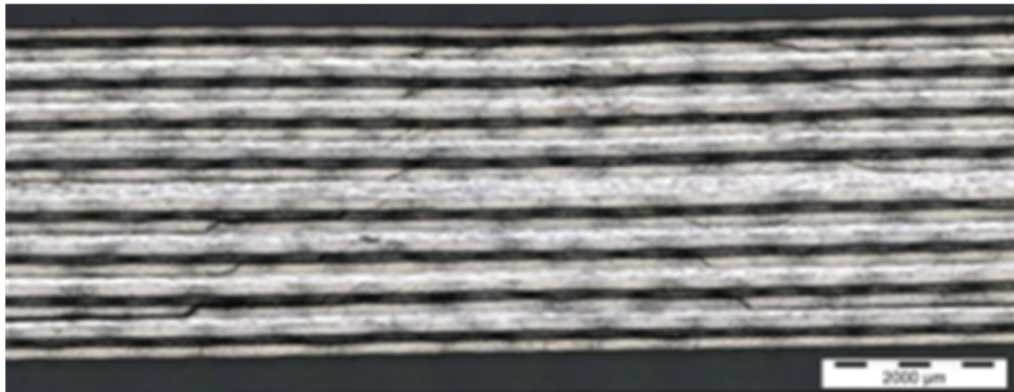
Fig. 8. Micrograph. All delaminations can be seen, although the contrast between the dark layers and cracks along those layers is low

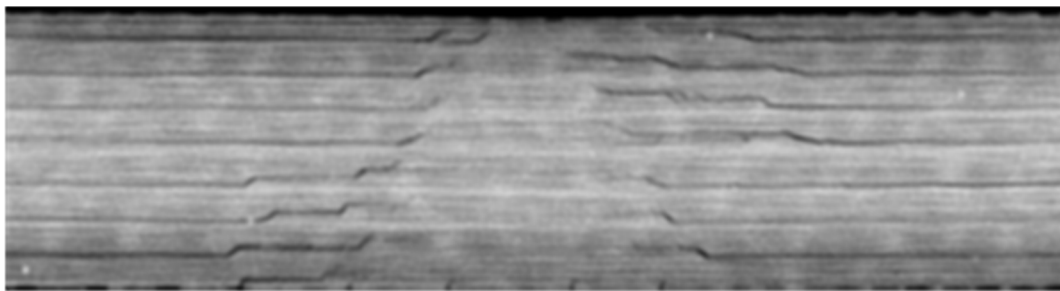
Fig. 9. CT cross-section. resolution is lower than in the micrograph, but the contrast between material and delaminations is high

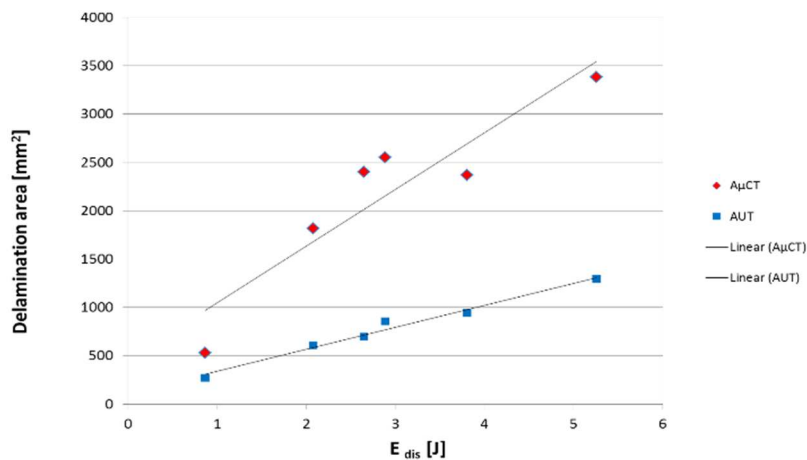
Fig. 10. Damage area vs. dissipated impact energy, red = μ CT measurement, blue = UT measurement, quasi-isotropic material

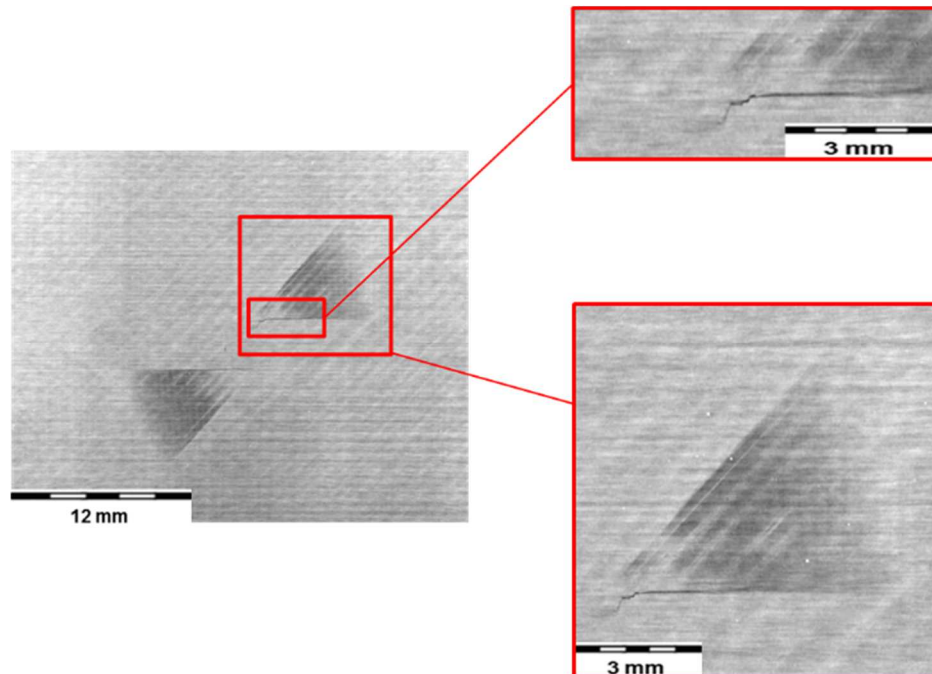
Fig. 11. μ CT picture of an impact damage in a depth of 0.4616 mm after an impact of 9.28 J. The detail views show interlaminar, plane cracks between the 90° and $+45^\circ$ layer (interface between layers 4/5) as delamination. The intralaminar crack (1) works as a crack starter/transducer

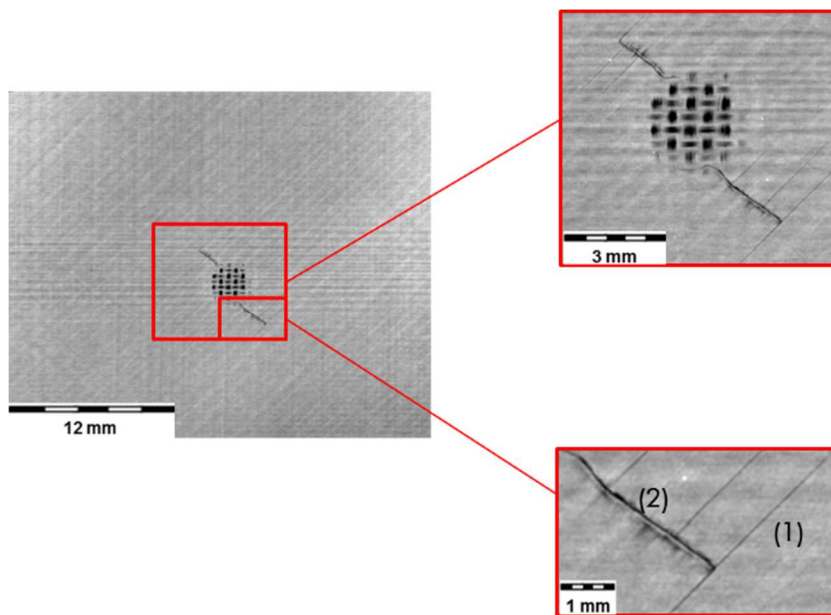
Fig. 12. μ CT picture of an impact damage in a depth of 0.033 mm after an impact of 9.28 J . Top right: Detail view of the specimen on the left hand side. Intralaminar cracks transverse to the fiber direction and fiber cracks. Compressed area in the center. Bottom right: Details of intralaminar cracks transverse to fiber direction (1) and fiber cracks (2)

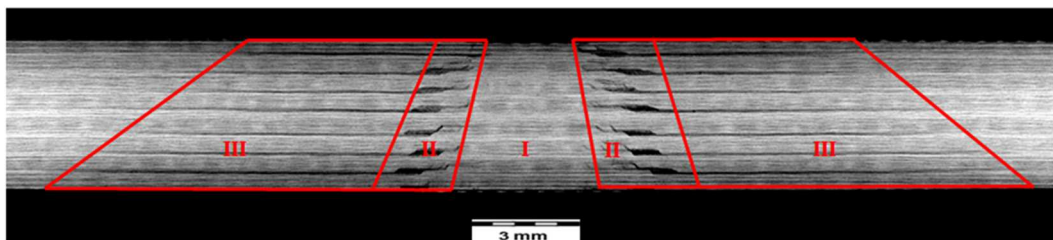
Fig. 13. μ CT picture of the delaminated cross section. Segments of the damage morphology are: (I) compressed cone segment, (II) inner cone segment ring with intralaminar cracks, (III) outer cone segment ring with interlaminar cracks, i. e. delaminations. The complete impact damage morphology – consisting of the above mentioned parts – is called delamination volume V_{del}

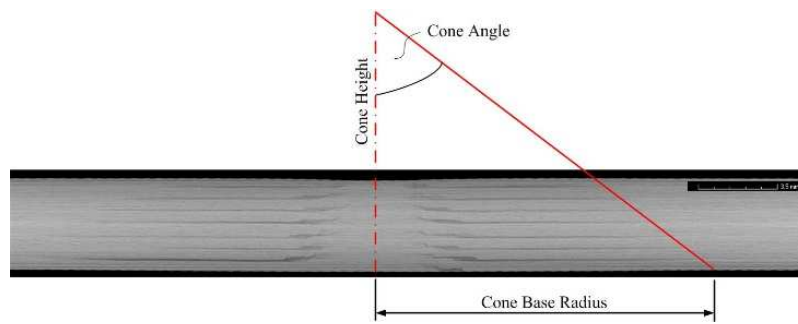
Fig. 14. Explanation of investigated damage parameters

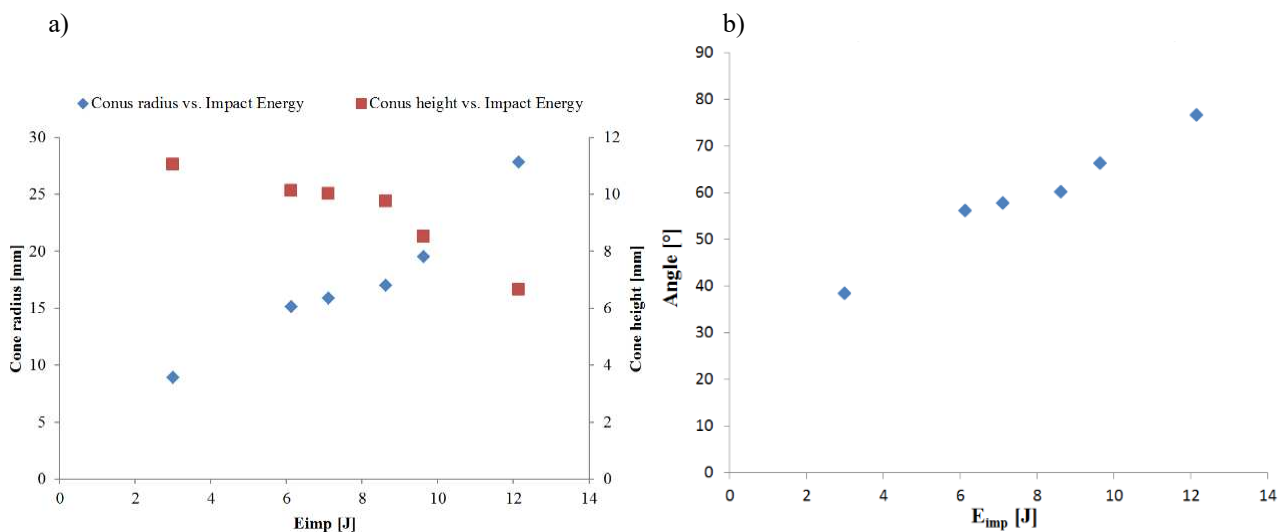
Fig. 15. a) Cone base radius and cone height versus impact energy, b) Cone angle versus impact energy
