Hydrogen degradation of high strength weldable steels

Purpose: Purpose of this paper is presentation of hydrogen degradation issue of high strength steels and especially their welded joints. Establishing of applicable mechanisms of hydrogen-enhanced cracking was the aim of performed research.

Design/methodology/approach: High strength quenched and tempered steels grade S690Q were used. Welded joints were prepared with typical technology used in shipyards. Susceptibility to hydrogen degradation in sea water under cathodic polarization was evaluated with the use of mechanical tests. Various kinds of loads were applied, i.e. monotonically increasing static, constant, and cyclic. Appropriate measures of hydrogen degradation were chosen and analyzed. Mechanisms of hydrogen degradation were detected and established on the basis of scanning electron microscopy (SEM) observation of fracture samples surface.

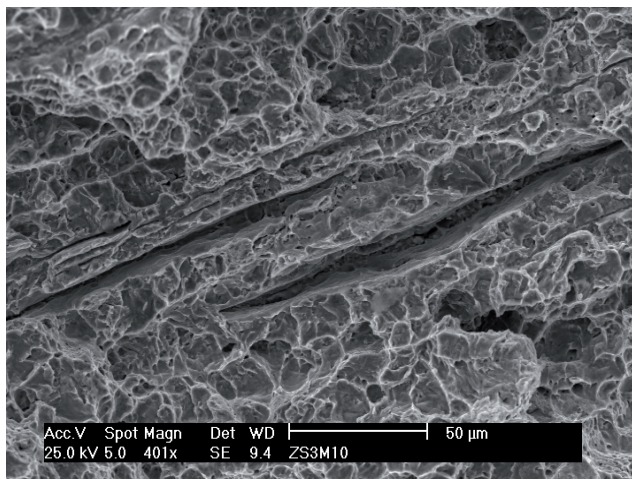
Fig. 2. SEM image of fracture surface of 17HMBVA steel sample with SAW welded joint after SSRT test in seawater, $i = 10 \text{ mA/cm}^2$. Fracture localized in weld metal

Samples with welded joints tested in air revealed ductile – MVC fracture mode. When cathodic polarization was applied mixed – MVC and quasi-cleavage fracture was observed. At higher cathodic current densities the presence of hydrogen induced microcracks and flakes in weld metal (Fig. 2). Obtained results of SSRT test and fractographic observations suggest that hydrogen-enhanced localized plasticity (HELP) model is the more applicable mechanism of hydrogen degradation. Hydrogen assisted-cracking occurs at load level as high as flow stress (yield strength) of tested steel and its welded joints.
