# Failure reasons investigations of dumping conveyor breakdown

### ABSTRACT

**Purpose:** The main purposes of the paper are to discuss designing and exploitation problems of machines used in strip mines and investigation of its reasons based on steering frame brake-down of the dumping conveyor.

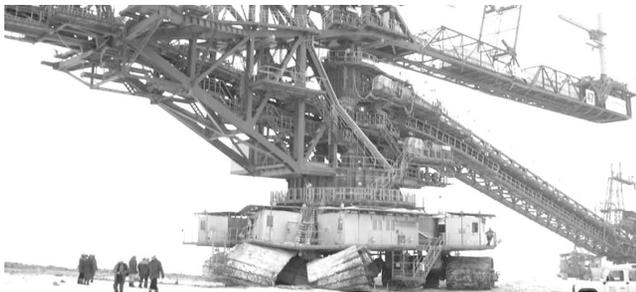
Fig. 2. Breakdown of dumping conveyor’s steerable carriage.

The dumping conveyor [6] is shown in fig. 2. The overburden which is to be removed from an open pit is transported to dumping conveyor for distribution [11].

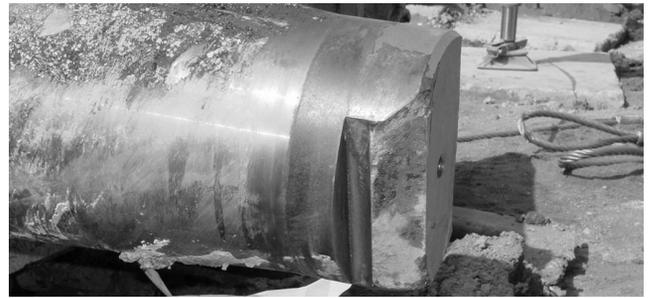
Fig. 4. Damaged halfshaft of steerable carriage

The breakdown occurred because one halfshaft slipped as a result of damage to its slip-out protection (fig. 4).

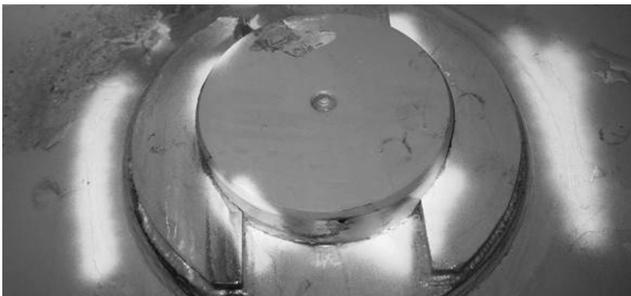
Fig. 7. Halfshaft end - protection against slip out

The protection against halfshaft slip out is shown in fig. 7.

The plates protecting the halfshaft against slip out were deformed as a result of the longitudinal movement of the halfshaft. Due to the axial clearance of the halfshaft static friction  $\mu = 0.09-0.14$  becomes sliding friction  $\mu = 0.01-0.05$ . The radius at the bottom of the groove for the protective plates equals  $r = 0.2$  mm. The halfshafts were made of toughened constructional alloy steel 42CrMoS4. The FEM strength calculations [7] were performed for two values of the axial force acting on the halfshaft protection: axial force  $F = 1393$  kN (curve travelling with radius  $R = 60$  m, neglected friction on the halfshaft mounting hubs), axial force  $F = 704$  kN (curve travelling with radius  $R = 60$  m, friction  $\mu = 0.09$  on the halfshaft mounting hubs). Figure 8 shows the distribution of Huber-Mises stress for radius  $r = 0.2$  mm and  $r = 4$  mm (adopted for comparison purposes) while the maximum Huber-Mises stresses on the groove's bottom are given in table 1. The FEM [15] calculations indicate that at the bottom of the groove with radius  $r = 0.2$  mm stresses considerably exceed the yield point.

It is concluded that the adopted protection is not good for this system of fixing the halfshafts. A much better solution is an annular protection with a properly large rounding radius of the halfshaft groove. The undercarriage system consisting of two
