## Investigations of causes of dumping conveyor breakdown

**E. Rusiński\***

Institute of Machines Design and Operation, Wrocław University of Technology,  
ul. Łukasiewicza 7/9 51-370 Wrocław, Poland

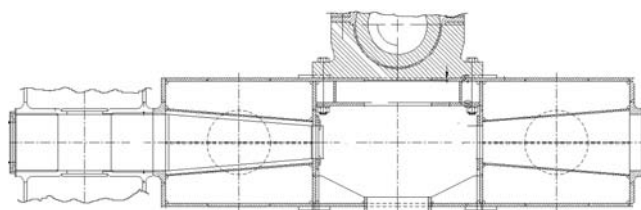
Fig. 5. Halfshaft mounting in carriage structure

This design solution is often used in order to reduce the machine's weight. In such machines the halfshafts are usually 3 m long and have a diameter of 500 mm, decreasing to 300 mm inside the carriage. The resulting mass amounts to about 3.5 tons. This design solution requires, however, solid support and protection against slipping out. The mounting of the halfshaft in the carriage box structure is shown in fig. 5.

The breakdown occurred because one halfshaft slipped out as a result of damage to its slip-out protection. The track girder after the breakdown is shown in fig. 6.

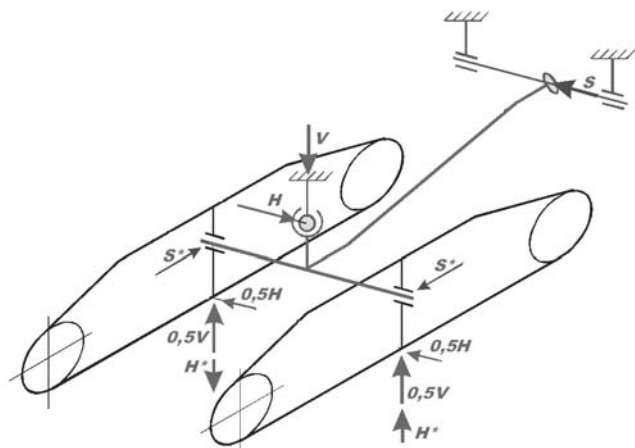
Fig. 8. Forces acting on caterpillar unit during turn

- curvature travel (L),
- caterpillar transverse slip (QQ),
- longitudinal dragging (LL), e.g. when the drive of one of the caterpillar tracks fails. In addition one should include the load from the body at a terrain gradient and wind pressure. The protection systems installed on surface mining machinery do not allow one to activate the turn mechanism when the machine does not move. A turn is possible only during travel. The loads acting on the caterpillar unit during curvature travel are shown in fig. 8.

The described case of loads analyzed in the FEM calculations played a major role in verifying the choice of bearing element cross sections.
