Half-shaft undercarriage systems – designing and operating problems

Purpose: The paper discuss designing and operating problems of half-shafts undercarriage systems of open pit machines. Example of failure of such system and investigation of its reasons are presented.

Findings: It was found that manufacturing and designing of the half shaft system were the main failure reasons. Such open pit machines undercarriages systems are prone to failures. Detailed analyses are required to implement half – shaft systems without risk of break-down. Recommendation is given in the paper for the single shaft system.

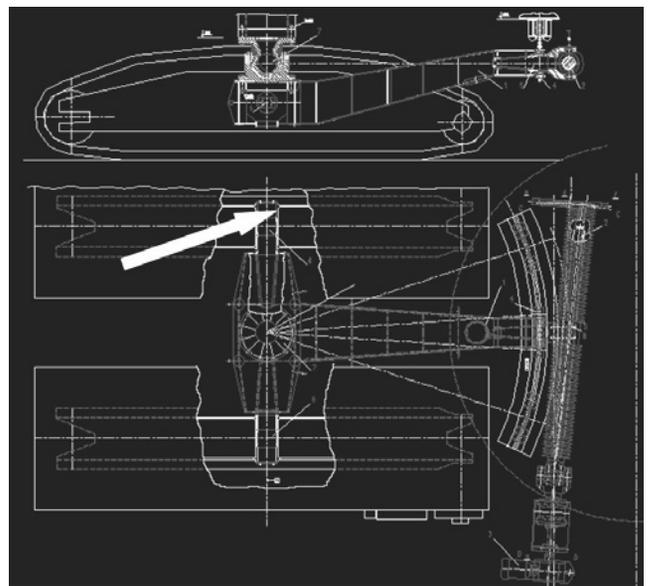
Fig. 4. Schematic of steerable caterpillar unit

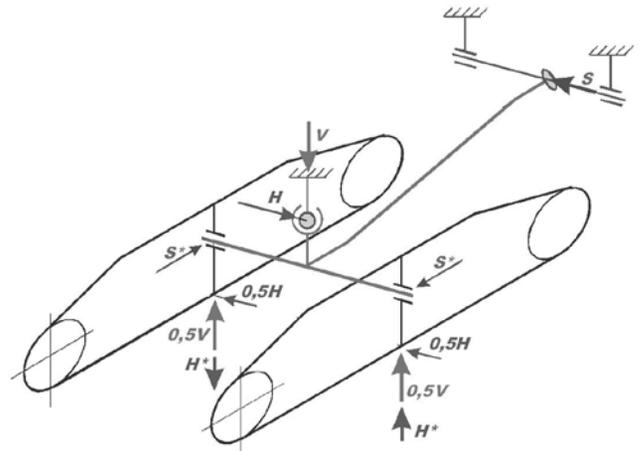
e.g. when the drive of one of the caterpillar tracks fails. In addition one should include the load from the body at a terrain gradient and wind pressure. The protection systems installed on surface mining machinery do not allow one to activate the turn mechanism when the machine does not move. A turn is possible only during travel. The loads acting on the caterpillar unit during curvature travel are shown in Fig. 8.

Fig. 8. Forces acting on caterpillar unit during turn

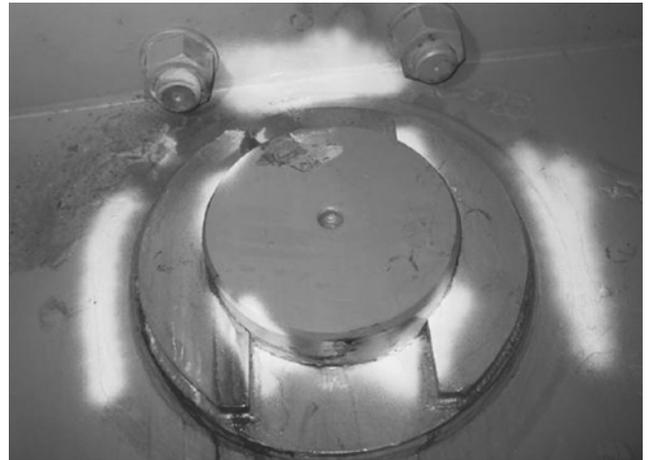
The loads acting on the halfshaft, particularly on its end where the slip-out protection is situated, were analyzed. Considerable axial forces produced by the side shearing of soil occur during curvature travel. In unfavourable conditions they and the lateral

forces due to the gradient and wind pressure may add up. The protection against halfshaft slip out is shown in Fig. 10.

Fig. 10. Halfshaft end - protection against slip out
