Effect of microstructural banding in hot-work tool steel on thermal expansion anisotropy

B. Pawłowski*, P. Bała, R. Dziurka, J. Krawczyk

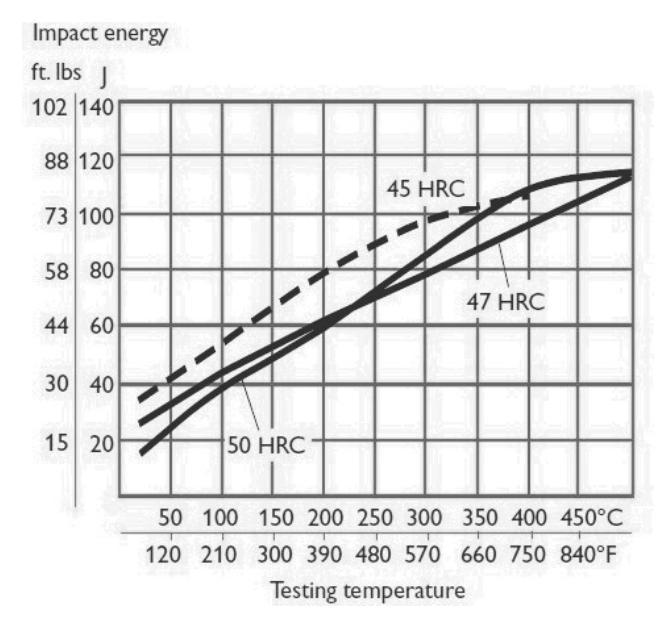
Fig. 4. Charpy V-notch impact toughness of investigated steel versus testing temperature, short transverse direction [12]

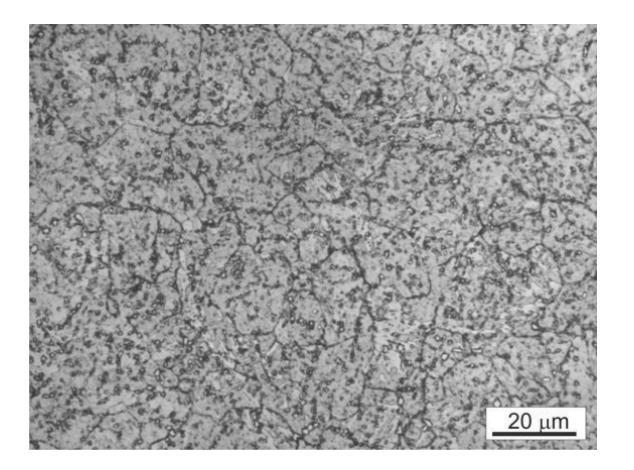
In the subsurface layer no decarburization regions and wear traces were observed, as it is presented in Fig. 15.

Fig. 15. Microstructure in the subsurface layer of investigated die (etched with 2% nital)

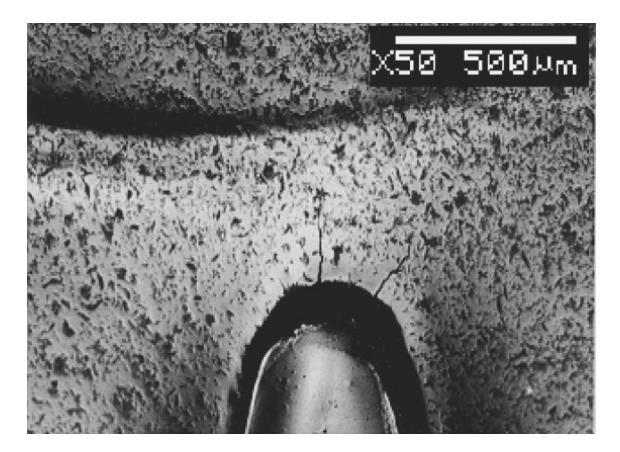
As it was reported in paper [14], cracks observed on the working surface of the die often initiates at identification marks, corners, sharp edges and transitions, as it is presented in Fig. 16.

Fig. 16. Surface cracks at edge of identification mark [14]

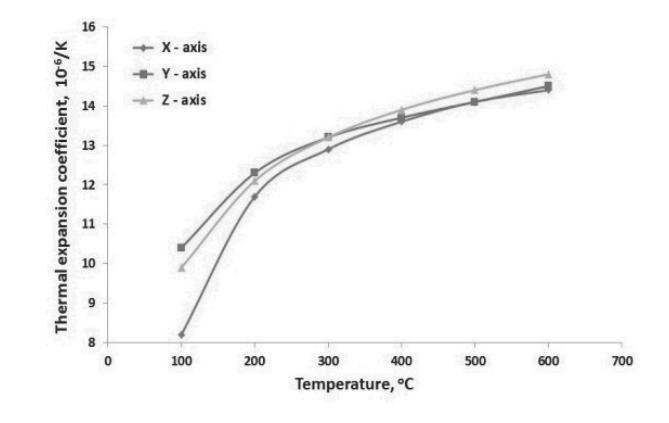
From the basic die material properties point of view, the thermal expansion coefficient ought to be low to get low thermal stresses and avoid heat check cracking. As it is shown in Table 1 and Fig. 20, a thermal expansion coefficient of investigated die showed a strong dependence upon the specimen orientation with respect to the microstructural banding direction. Such considerable differences in values of thermal expansion coefficient between values for X-axis and both Y and Z-axis could play significant role as an additional factor determining the cracks direction (parallel to the X-axis).

Fig. 20. Thermal expansion coefficient versus sample orientation
