## Manufacturing and damage mechanisms in metal matrix composites

**Purpose:** Mechanical properties of metal matrix composites (MMCs) are essentially functions of the manufacturing processes. Surface state and roughness conditions as well as the type of matrix reinforcement and heat treatment influence the mechanical behaviour of the MMCs in service conditions. The factors such as the porosity of the matrix, volume fraction of the reinforcement and their distribution, agglomeration or sedimentation of particles and particle size, dross and porosities influence the behaviour of the MMC. The static and cyclic deformation behaviour of these two metal matrix composites has been investigated at room temperature; 2124/Al-Si-Cu fabricated by powder metallurgy and AS7G/Al-Si-Mg fabricated by foundry.

**Originality/value:** Manufacturing of two new different MM-composites and damage analysis in successful usage of aerospace application.

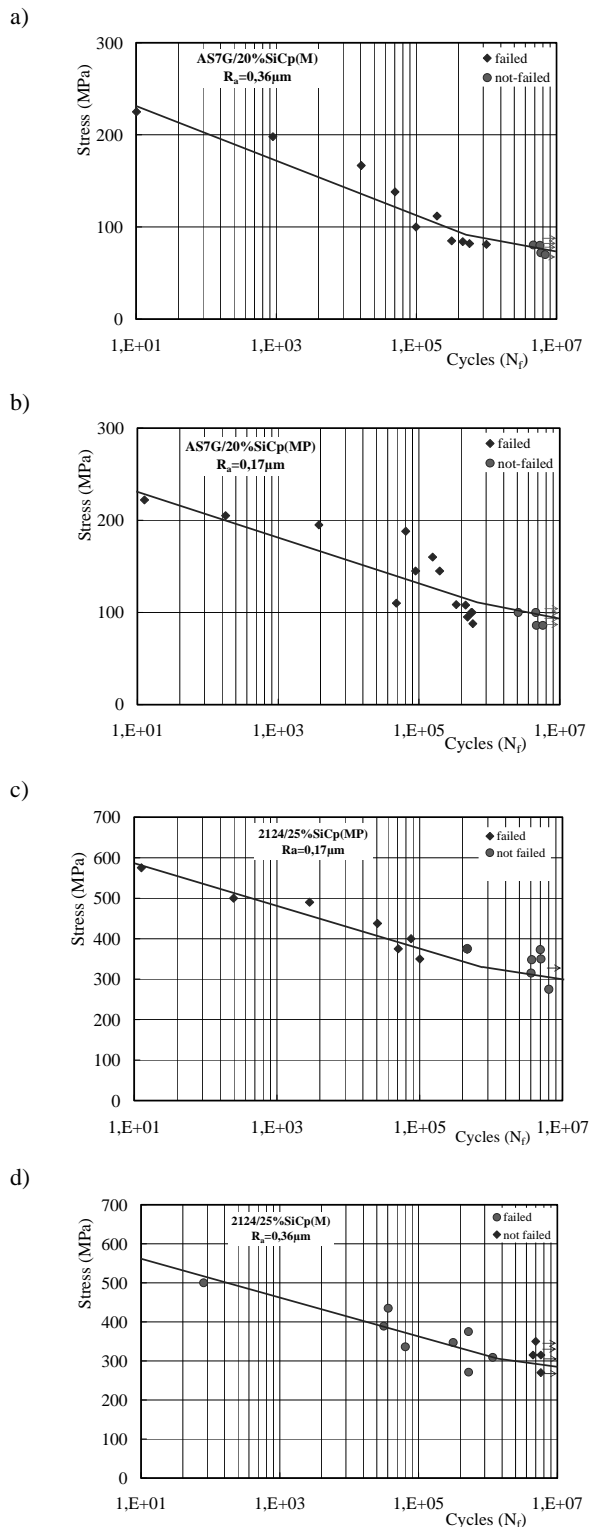
Fig. 5. Fatigue test results for two different materials at the stress ratio of 0.1 and the frequency of 30 Hz; a) AS7G (polished), b) AS7G (not polished), c) 2124 (polished), d) 2124 (not polished)

Fig 5 displays the fatigue test results obtained on the two composites; 2124 and AS7G. The fatigue properties explained by S-N curves were plotted in polished and also as received conditions of the specimens for both of the two composites. These S-N curves showed that the fracture occurred between  $10^6$  -  $10^7$  cycles ranges. AS7G shows significantly lower fatigue strength with the fatigue strength at  $10^6$  cycles of 95 MPa regarding to 2124. The fatigue strength ( $\sigma_D$ ) value found for 2124 is about 363 MPa [6-11]. It is seen that the particle size and the production methods are the main parameters playing an important role on the fatigue strength. These results are in agreement with the literature [1-11, 16, 19, 20, 23, 28].

However, at high applied stresses, a considerable scatter of the data can be seen. There is no considerable effect of the surface roughness conditions on the fatigue behaviour of the composites studied here. In fact, a good correlation between fatigue strength and tensile strength are generally found in a wide variety of materials. Here, the fatigue strength decreased particularly in AS7G, thus leading to a low fatigue ratio (fatigue strength/tensile strength ratio). Such a low fatigue resistance of this composite can be attributed to a low crack initiation resistance due to the interface debonding between the SiC particles and the matrix.
