Models of damage mechanism of glidcop Cu-Al₂O₃ micro and nanomaterials

Purpose: of this paper was to analyze the fracture mechanism before and after ECAP in the Glidcop AL-60 grade (with 1.1 wt. % of Al₂O₃) system and to propose damage and/or fracture mechanisms models by means of the method “in situ tensile test in SEM”.

M. Besterčí, K. Sülleiová, B. Ballóková, O. Velgosová, Models of Damage Mechanism of Glidcop Cu-Al₂O₃ Micro and Nanomaterials, Journal of Achievements in Materials and Manufacturing Engineering 69/2 (2015) 79-85.

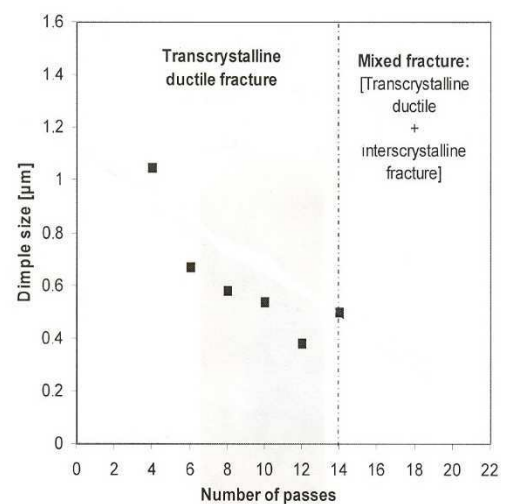
Fig. 1. Dimple size in dependence on number of ECAP passes

In a work [2] two fracture micromechanisms of nano Cu are identified by the fracture surface analysis (see Fig.1).

Fracture surfaces up to 14 ECAP passes (90° channel angle) had transcrystalline character with the dimple morphology. With the growing number of ECAP passes, the dimple size decreases and the quantity of dimples increases. Dislocation coalescence and changes in the triple grain junctions manifested by the increasing number of profile vertices with the amount of deformation are the probable fracture mechanisms affecting the fracture initiation, i.e. the first stage of the ductile fracture formation. Void growth and

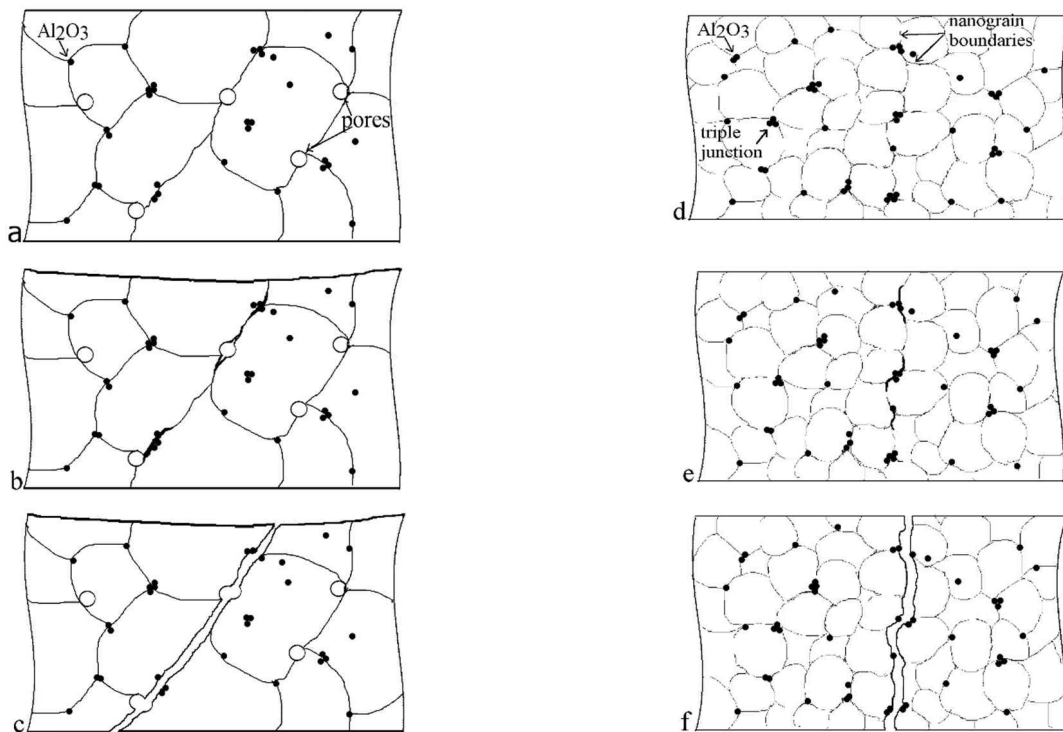
Fig 9. Model of the fracture mechanism before ECAP (a, b, c) and after ECAP (d, e, f)

Based on the microstructure changes observed in the process of deformation, the following model of the fracture mechanism before ECAP was proposed, Fig. 9 a, b, c:

- the microstructure in the initial state is characterized by Al_2O_3 particles their clusters and pores in matrix,
- with increasing of tensile load local cracks on pores occurred, there are cracks formed by decohesion of Al_2O_3 particles and clusters,
- with further increase of deformation of the material crack propagates preferentially along the pores and decohesed particles and clusters in a 45° angle.

The following model of the fracture mechanism of the ECAPed material was proposed, Fig. 7d, e, f:

- initiation of fracture is caused by cracks in triple junctions as well as by decohesion of Al_2O_3 particles and clusters in the middle of the specimen,
- fracture is propagated very quickly at minimum plastic deformation,
- fracture is perpendicular to the tensile loading of the specimen.
